MADISON LEWIS WOODLANDS CULTURAL LANDSCAPE REPORT
*CHAPTER III: MADISON LEWIS WOODLANDS LANDSCAPE
EXISTING CONDITIONS*

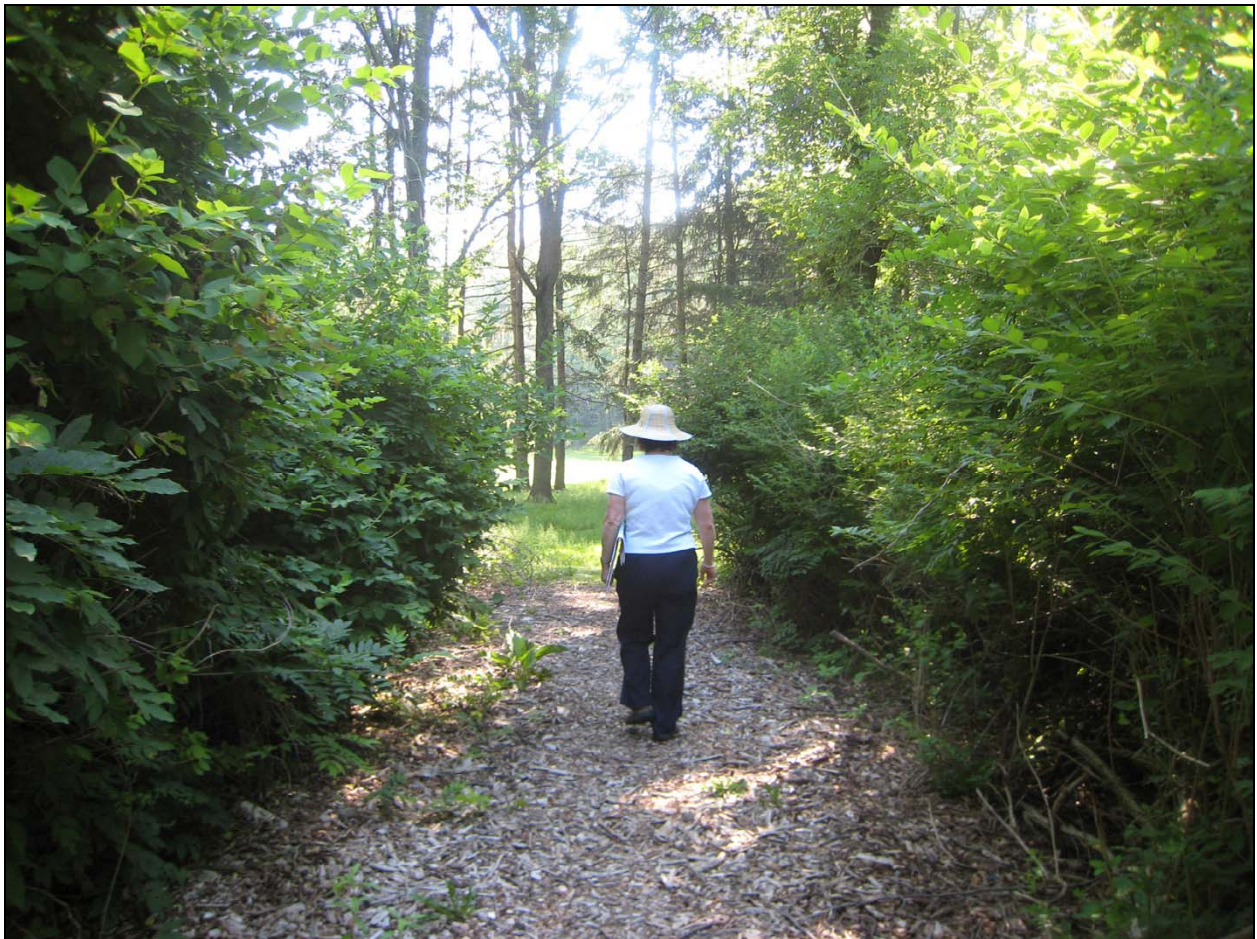
Figure III.1. The entry walk into the Madison Lewis Woodlands is lined by prolific tatarian honeysuckle, an invasive shrub. The wood chip covered walk leads into the former garden space. Courtesy Heritage Landscapes. (R-MLW-10June2008-0002.jpg)

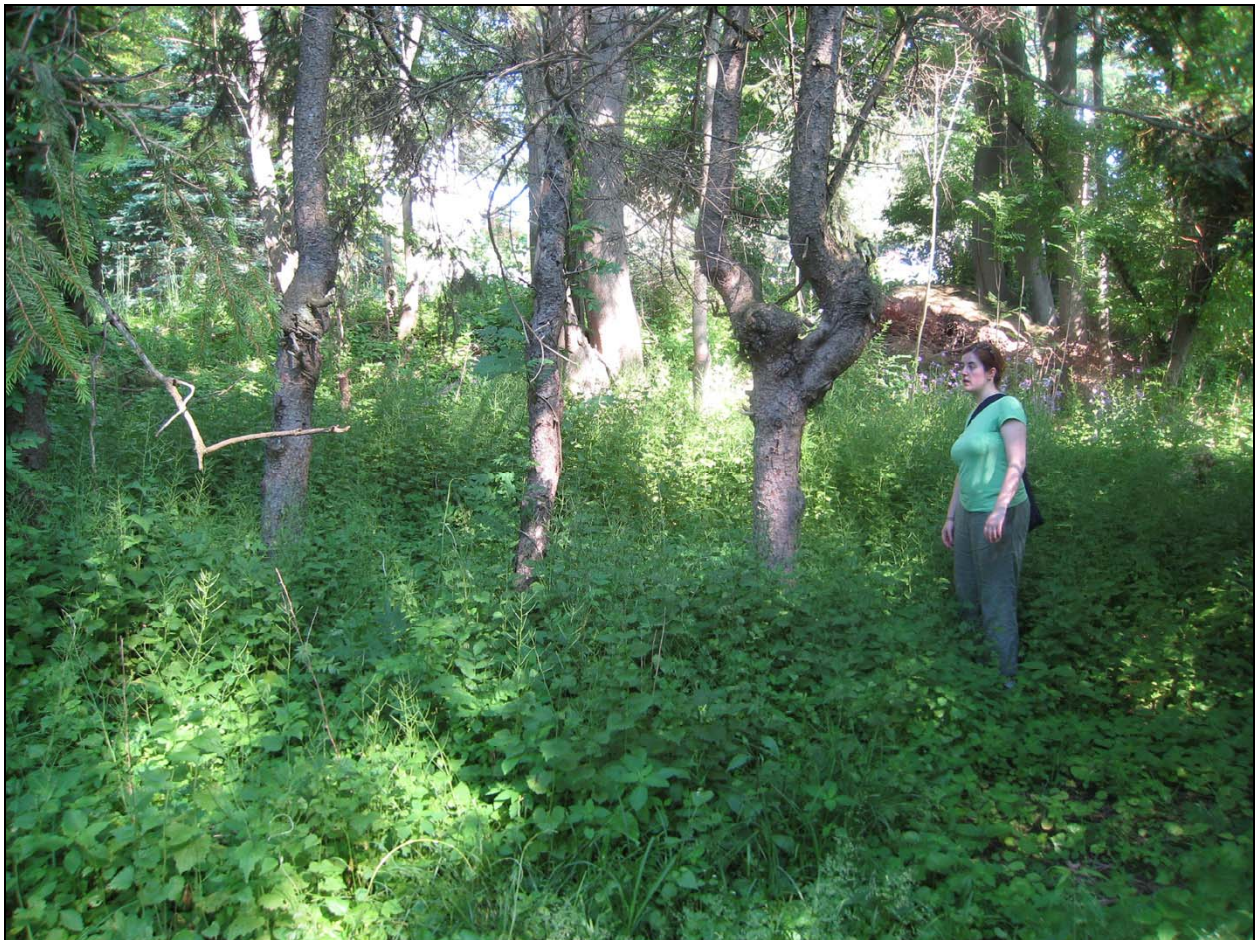
Figure III.2. These three white spruce trees form part of a former hedge that continues to mark the west edge of the former Italian Garden space. The prominent markings approximately five feet high on the trunks indicate that these trees were historically pruned to be maintained at a consistent hedge height. Courtesy Heritage Landscapes. (R-MLW-10June2008-0005.jpg)

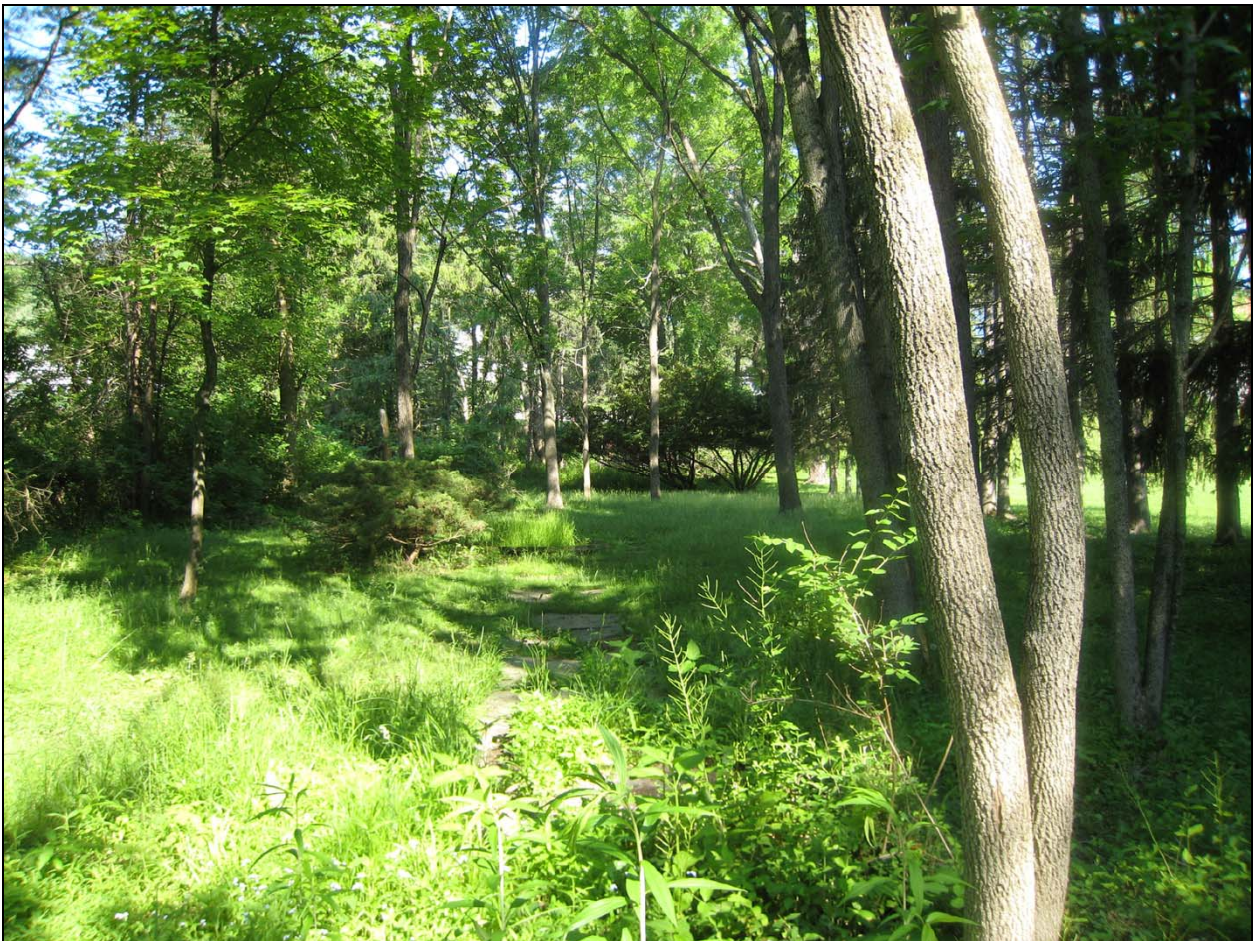
Figure III.3. This view looking west across the garden space shows several existing landscape features. A path of bluestone pavers extends down the center of the image with the turf-filled stone fountain basin visible at the approximate center. A historic Andorra juniper grows to the south (left) of the basin. A large historic yew shrub is visible toward the rear of the garden space, right of center. Original white spruce trees mark the north and west edges with a considerable amount of volunteer and invasive vegetation growing throughout the space. Courtesy Heritage Landscapes. (R-MLW-10June2008-0023.jpg)

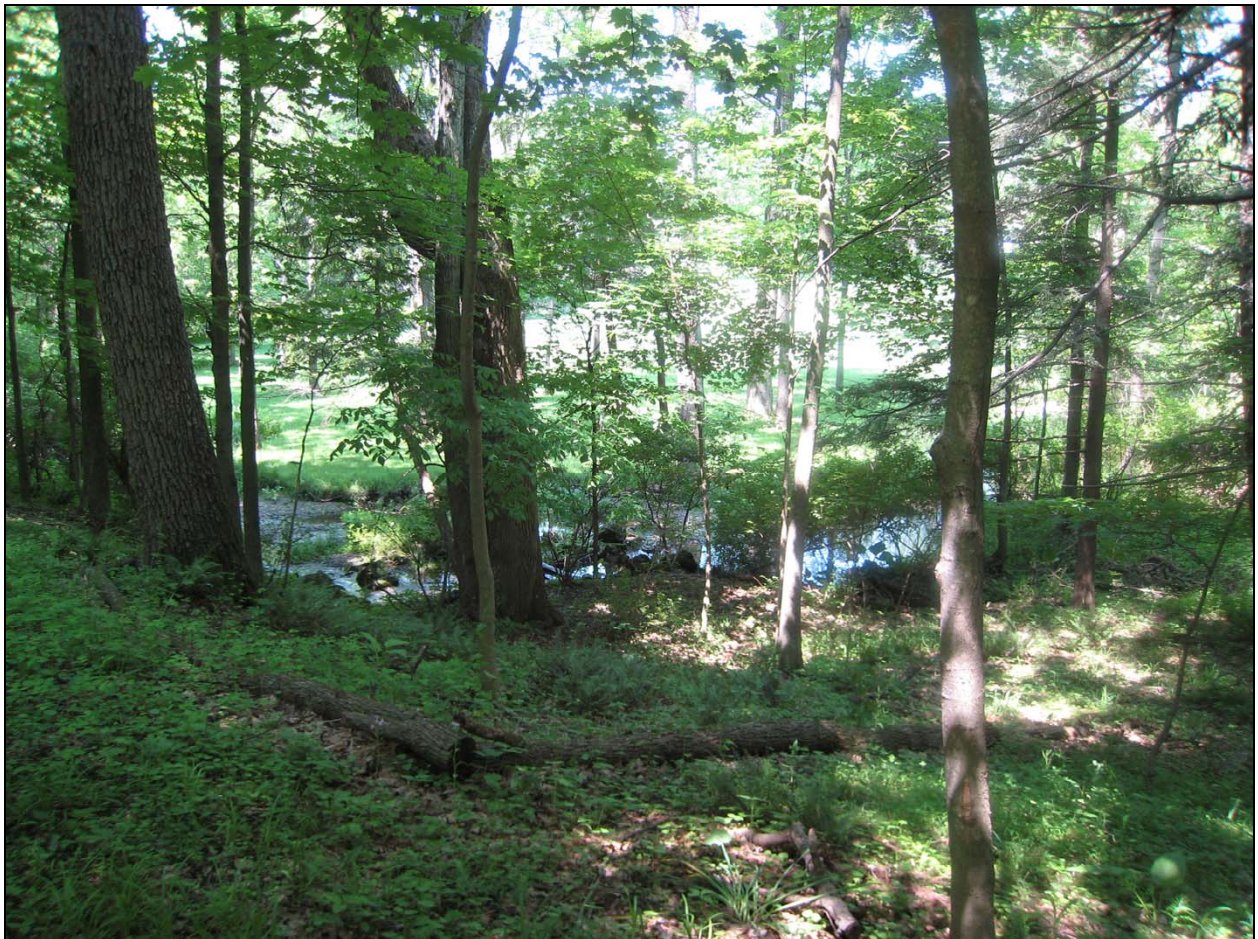
Figure III.4. Views of the gentle curve in the stream are partially obscured by vegetation. Large linden and walnut trees grow on the downslope between the path and stream. Fern, American hogpeanut, and garlic mustard cover the sloping ground plane. Courtesy Heritage Landscapes. (R-MLW-10June2008-0154.jpg)

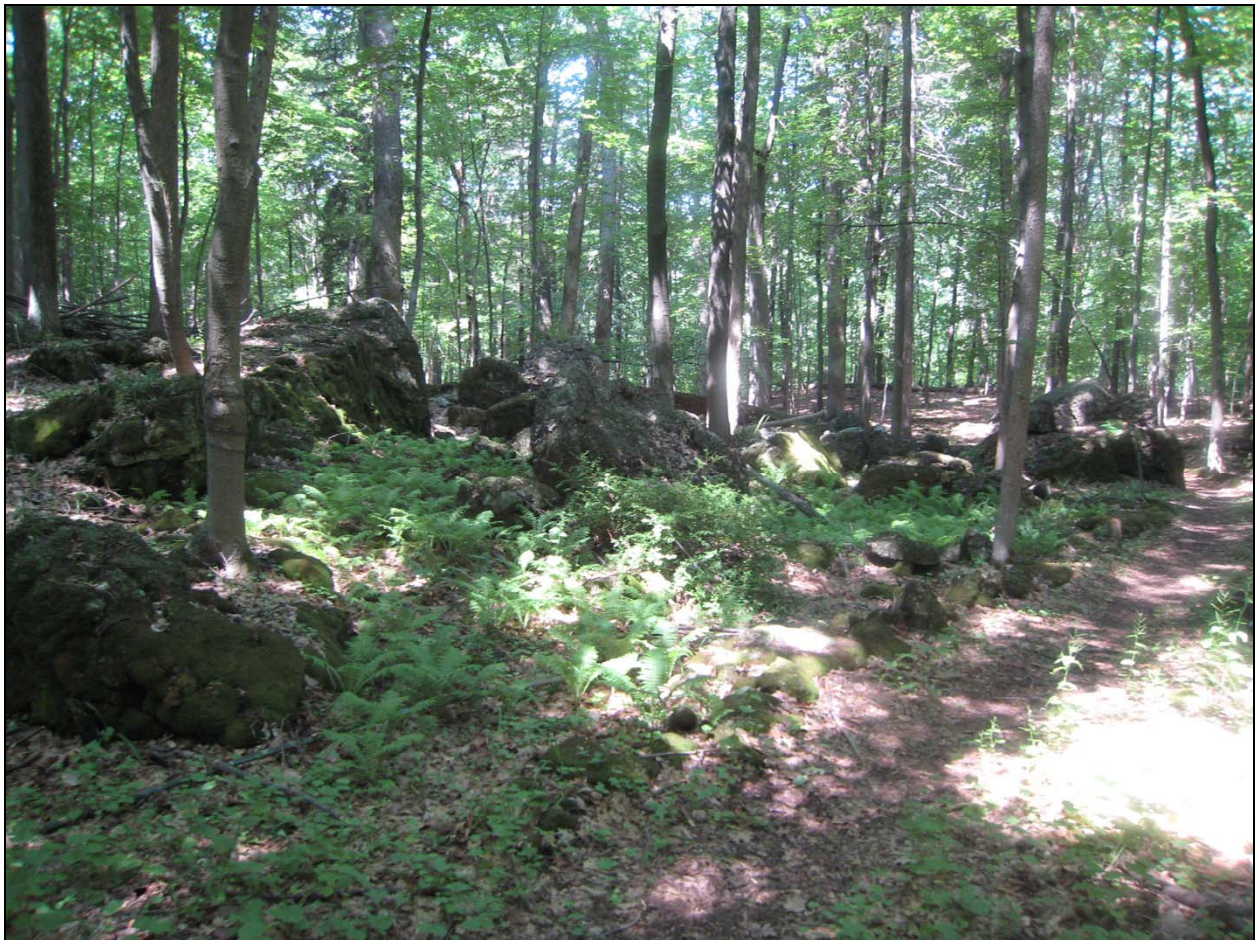
Figure III.5. Natural features within the woodlands, such as these rock outcrops, contribute to the landscape character. Stone was added to features to enhance this natural character. Here, stone lines the path edge. Fern and barberry grow on the woodland floor, creating interesting textures in the dappled light. Courtesy Heritage Landscapes. (R-MLW-10June2008-0140.jpg)

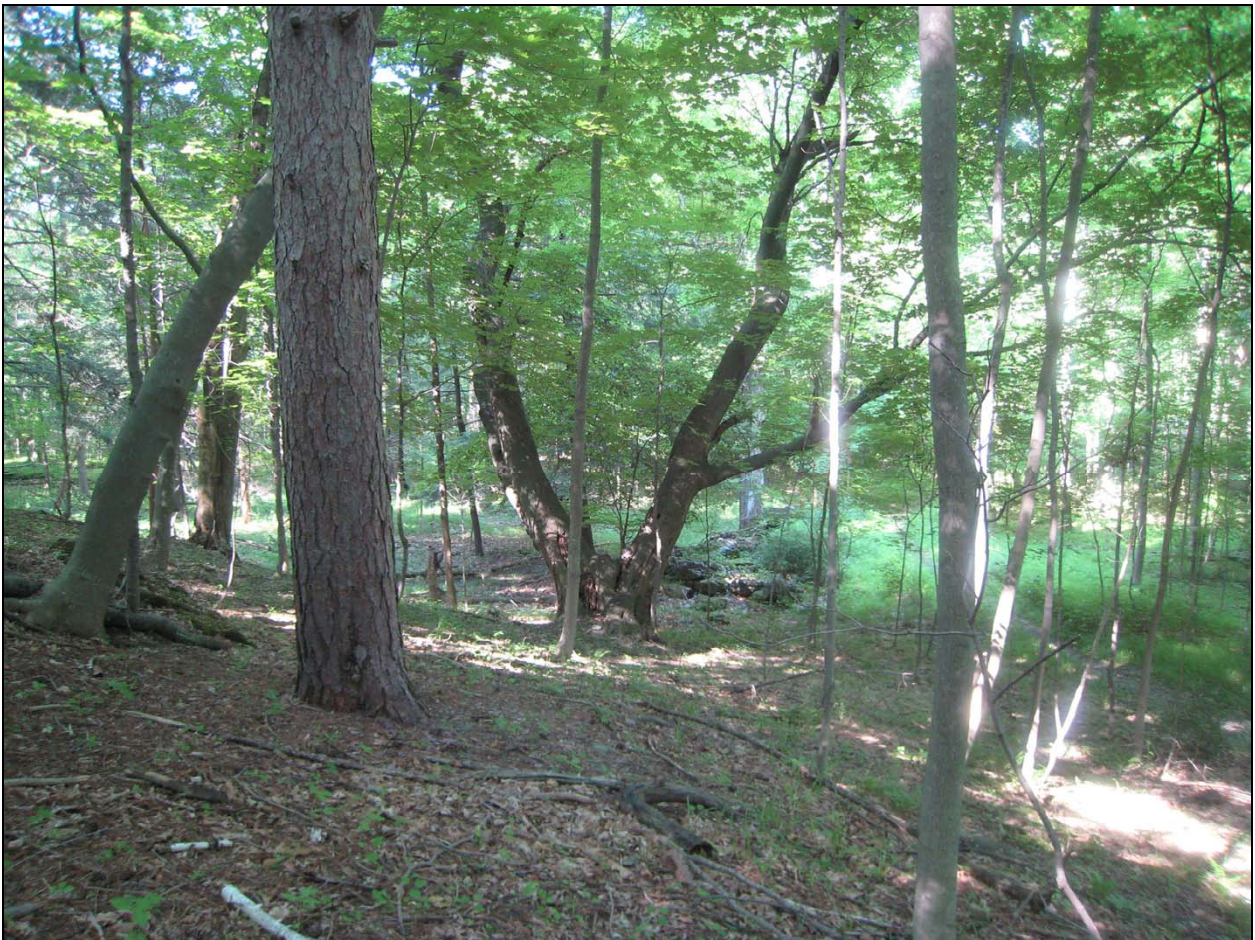
Figure III.6. The large yellowwood visible at the center of the image likely predates the historic period. Its branching pattern indicates it matured in an open area, with few surrounding trees to inhibit the spreading growth. Other tree species found in this area include mature hemlock, white pine, and arborvitae. A stone pile is visible just beyond the yellowwood. Courtesy Heritage Landscapes. (R-MLW-10June2008-0055.jpg)

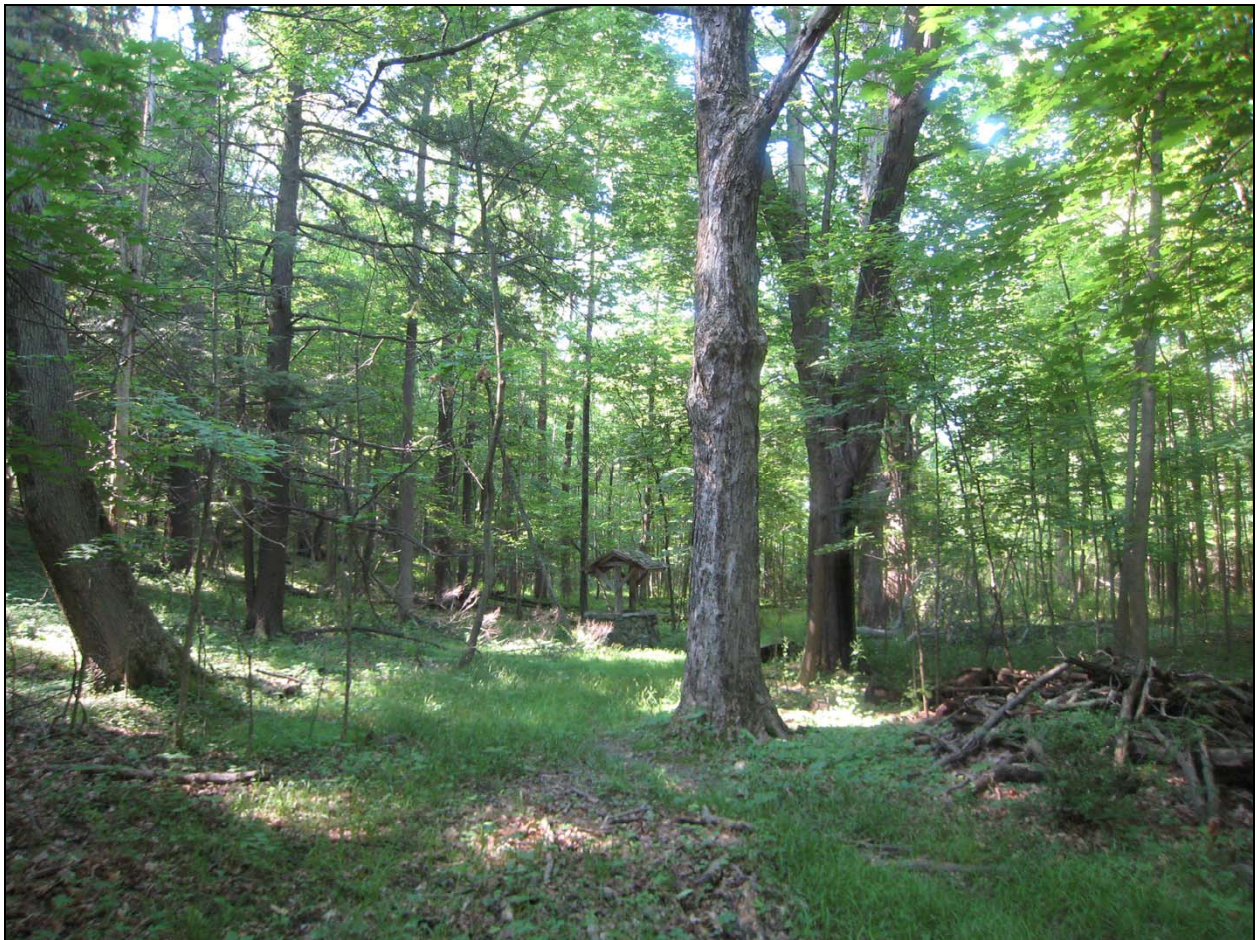
Figure III.7. The historic stone well, visible at center, is one feature remaining from the Fowler playhouse landscape. The row of sugar maple trees growing to the west (right) of the well mark the location of the former playhouse. The trees were planted along the front façade of the structure during the historic period. Courtesy Heritage Landscapes. (R-MLW-10June2008-0046.jpg)

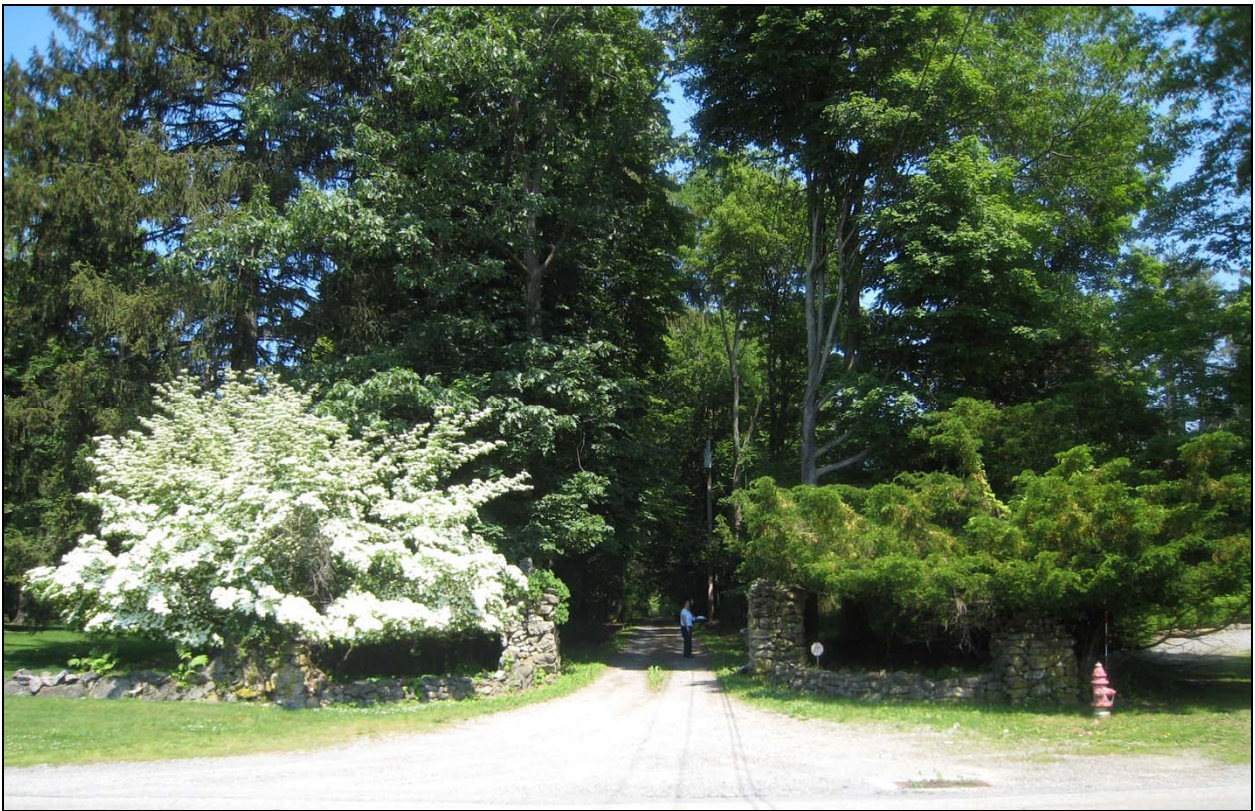
Figure III.8. Stone piers that remain from the Fowler period mark the historic secondary entrance into the Belair estate grounds from Colonial Avenue. The drive is lined by a historic tree allée and while new plantings have been added, several of the existing trees date from the historic period. Although not included in the 14-acre public park, this feature provides insight into the intended diversity and effect of vegetation planted at the Belair estate. Courtesy Heritage Landscapes. (R-MLW-10June2008-0104.jpg)

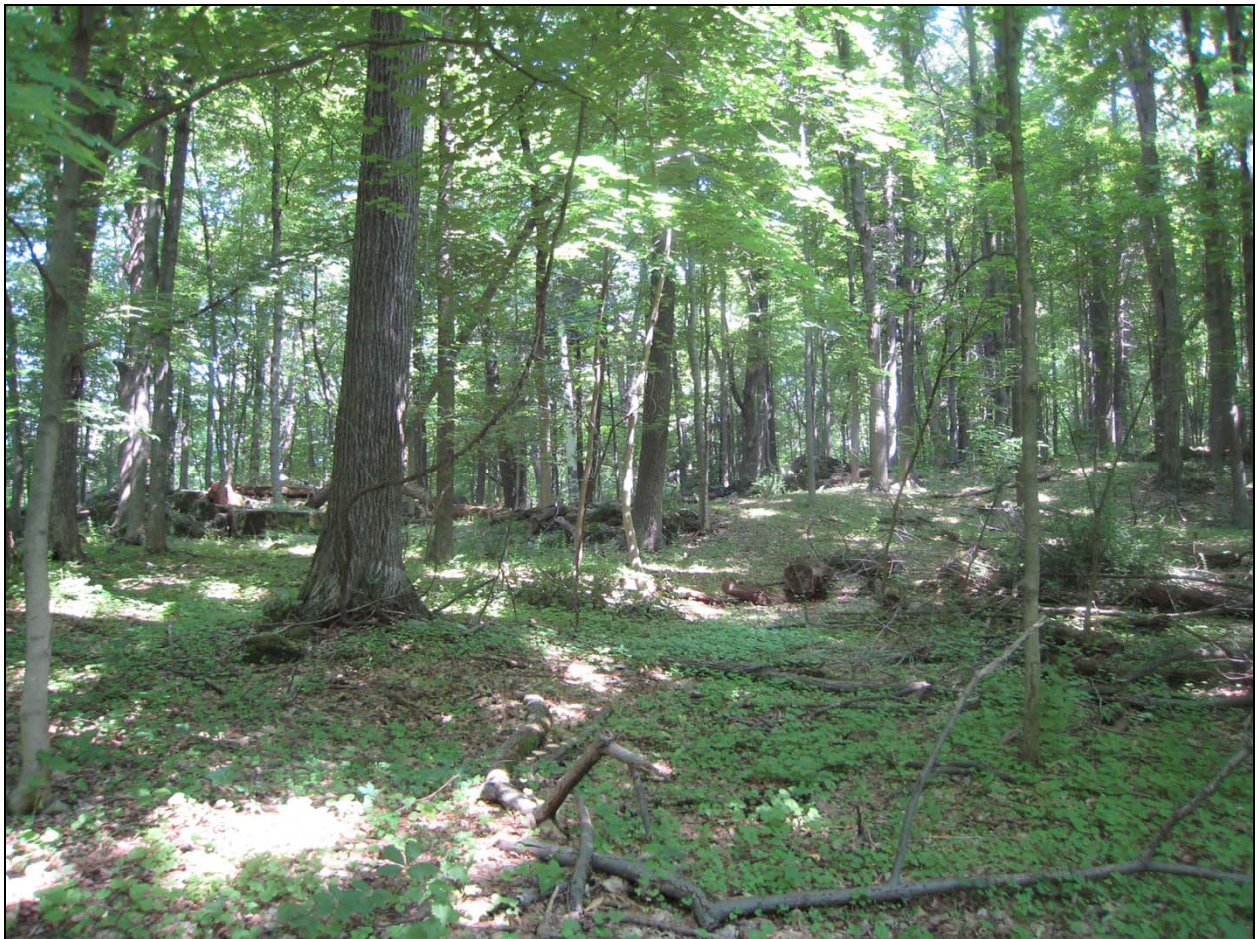
Figure III.9. This view illustrates the area of the woodlands dominated by American linden trees. A number of black walnut trees also grow in this area, located toward the east edge of the property. Courtesy Heritage Landscapes. (R-MLW-10June2008-0125.jpg)

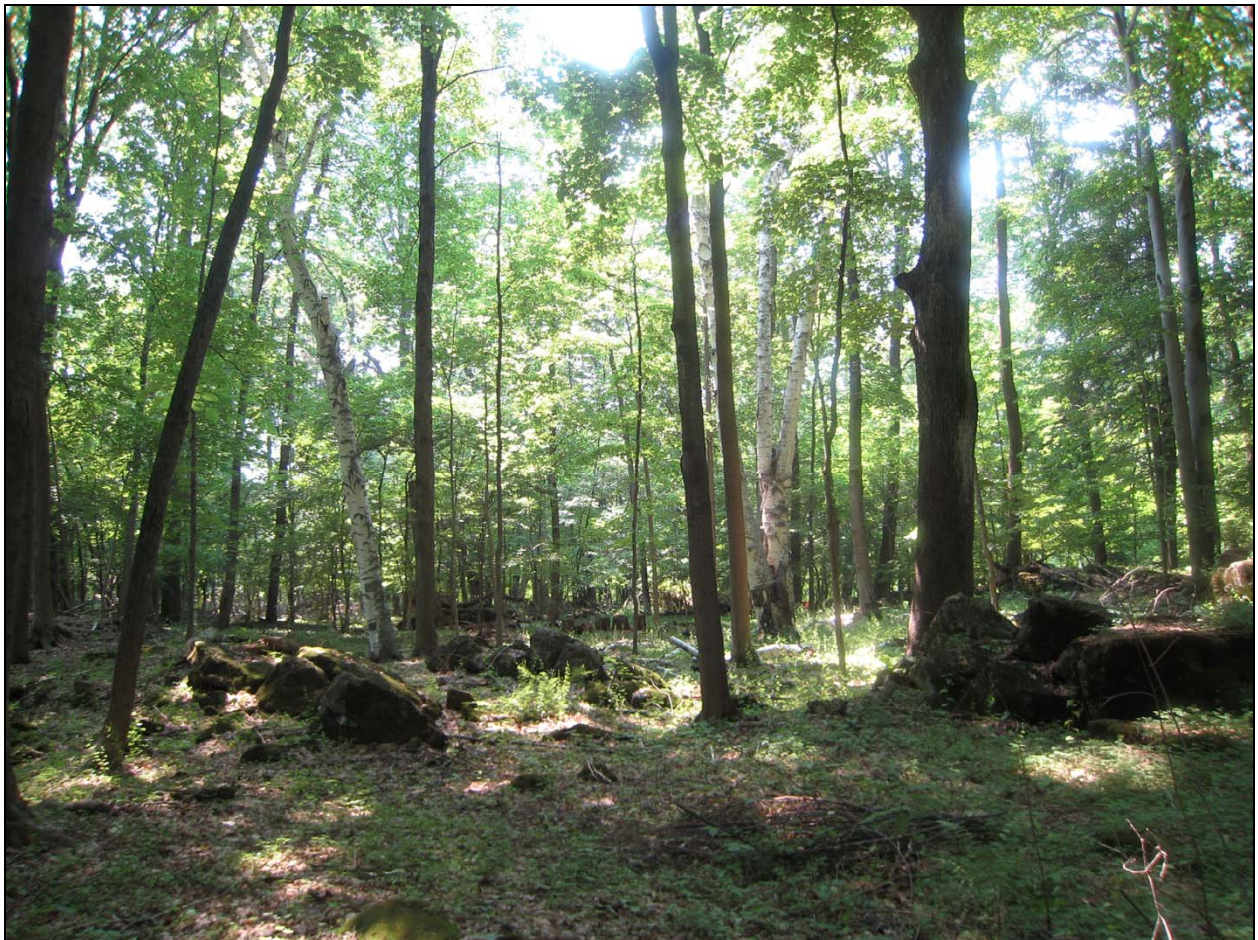
Figure III.10. A transitional woodland type is present between the American linden dominant area and the red and white oak dominated area. Here, sugar maple is prominent with clusters of white spruce and pine and scattered hemlock, beech, cherry, and white birch trees evident as well. Courtesy Heritage Landscapes. (R-MLW-10June2008-0173.jpg)

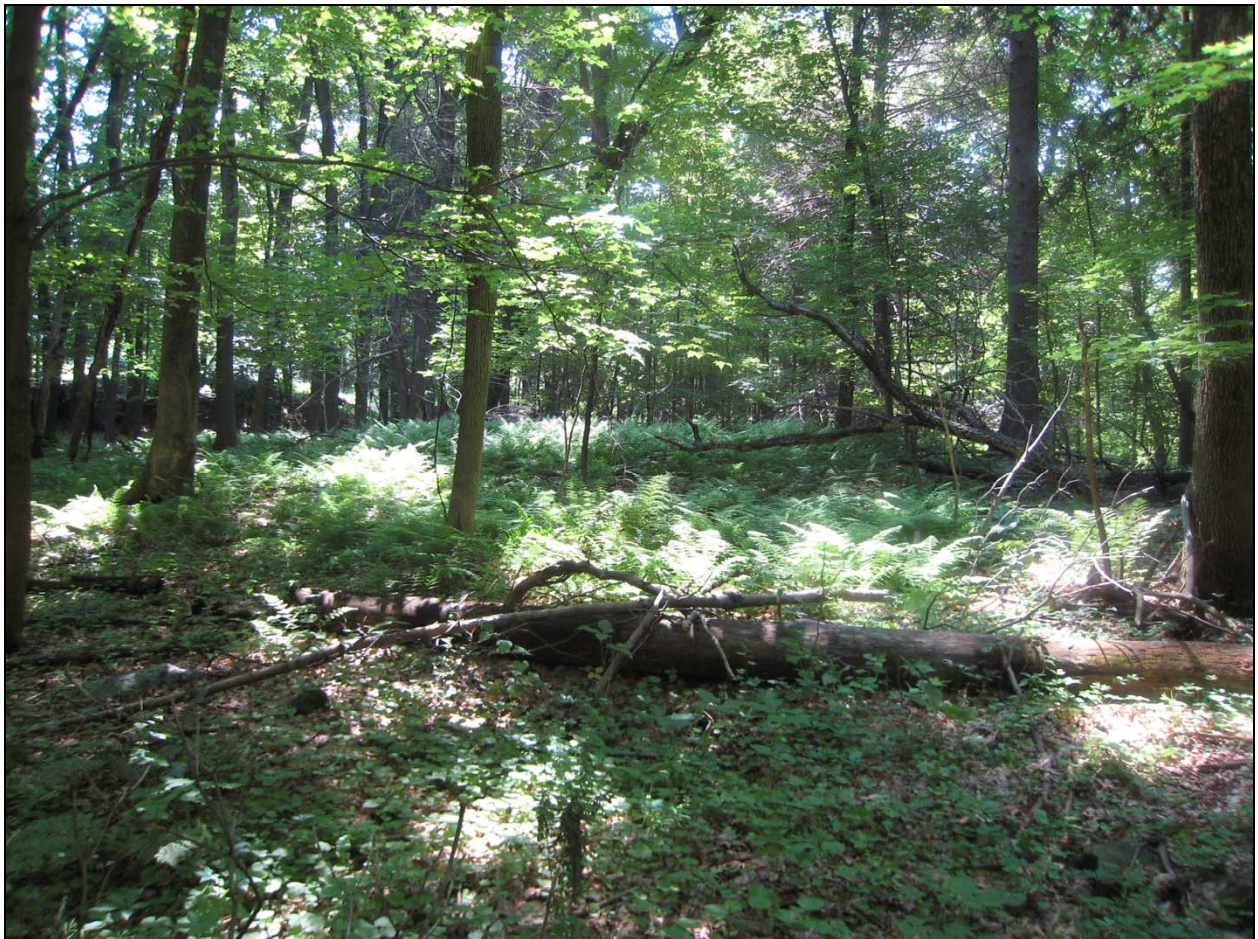
Figure III.11. This view depicts an area characterized by oak trees and rhododendron plantings that grow alongside the path. This patch of hayscented fern grows to the east of the path. Courtesy Heritage Landscapes. (R-MLW-10June2008-0133.jpg)

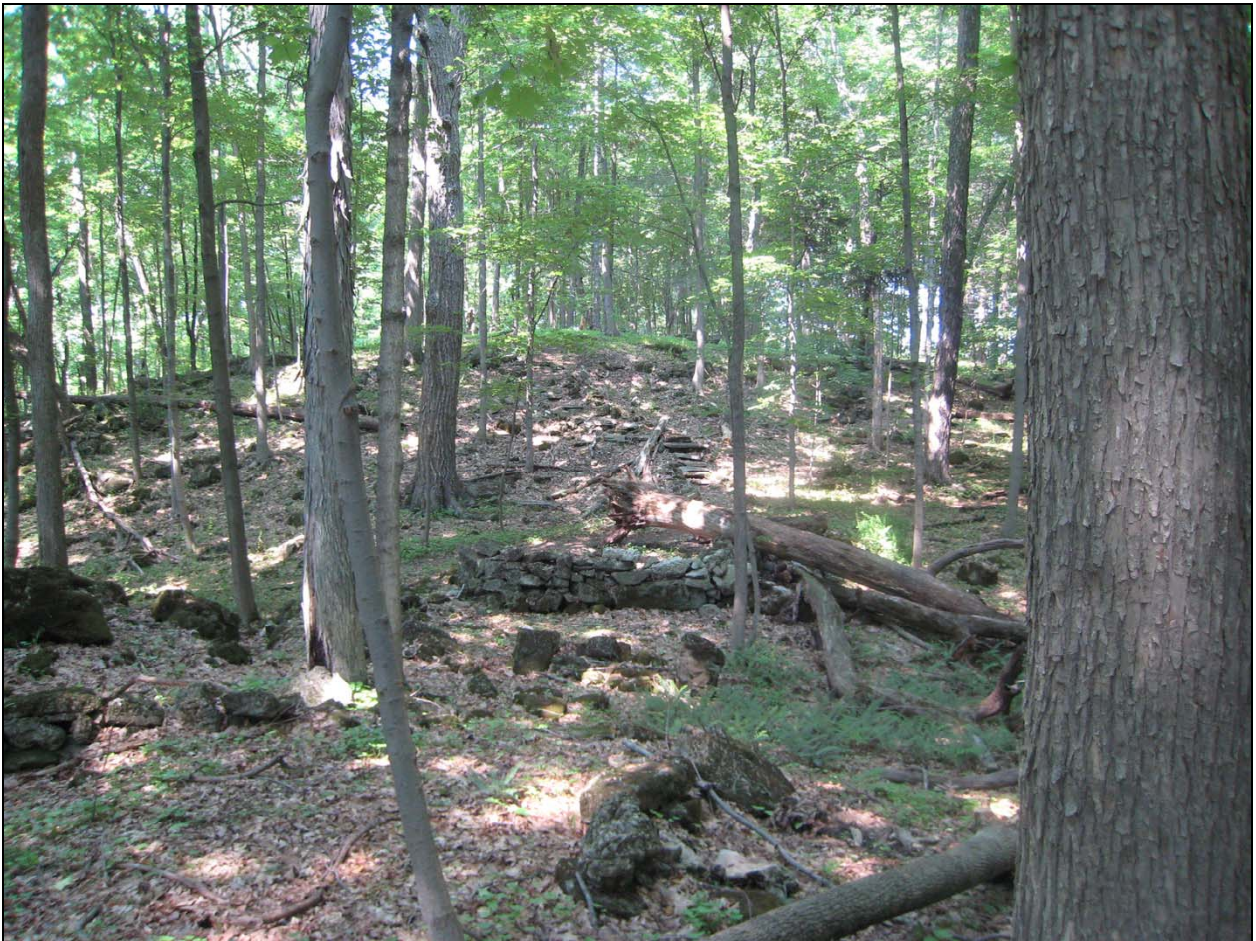
Figure III.12. View along a former carriage path that is not part of the preserve trail system reveals remnant historic features. The stone feature visible at the center of the image is a historic stone abutment that supported a rustic bridge, which crossed the dry ravine beyond. In the background, a historic stone stairway is visible. Fallen trees are strewn across the ground plane and over the historic stone feature. Courtesy Heritage Landscapes. (R-MLW-10June2008-0177.jpg)

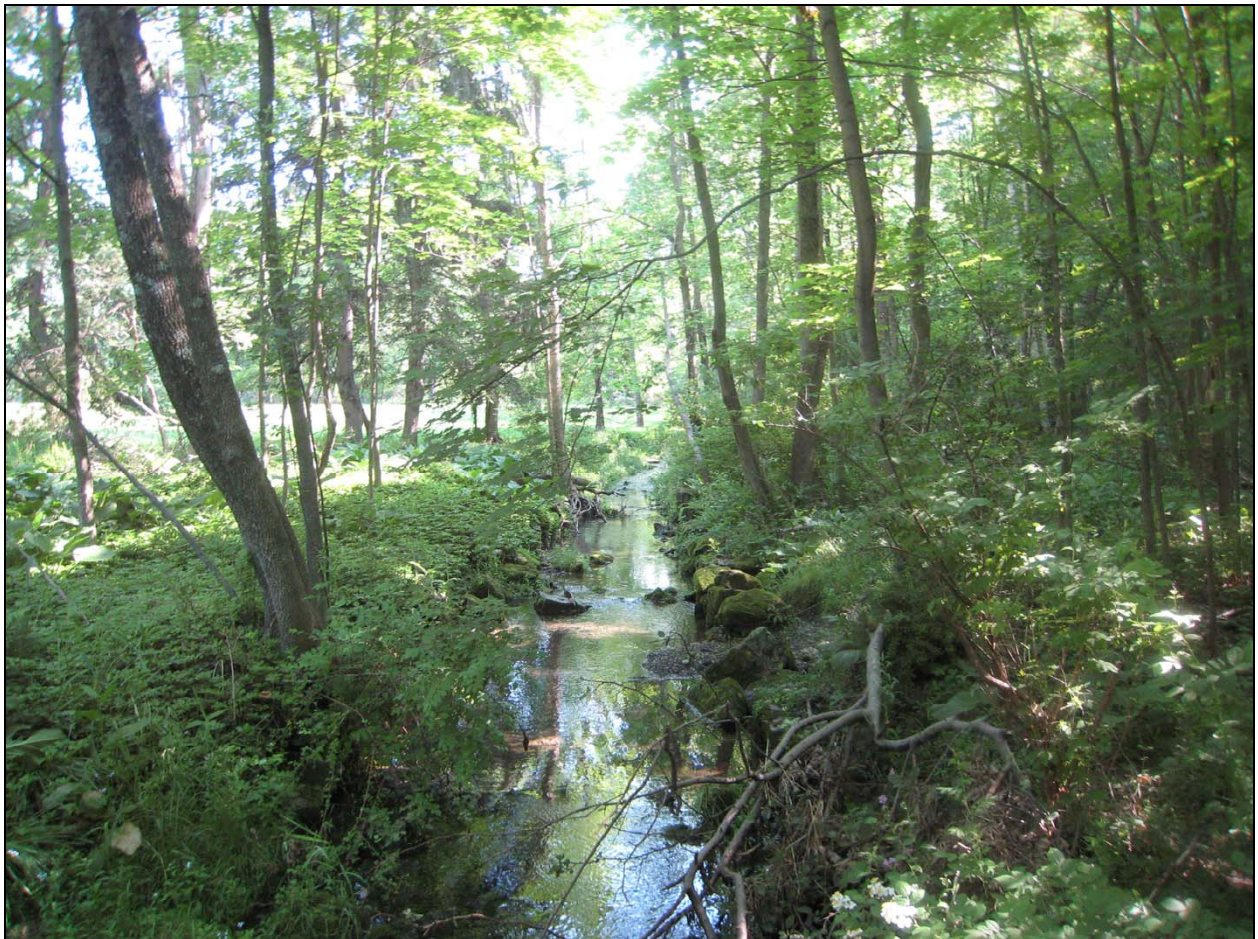
Figure III.13. A natural stream runs through the site from north-south, separating the garden space from the woodlands and walking trails. The character of the stream compliments that of the woodlands, although views of the stream are obscured. Courtesy Heritage Landscapes. (R-MLW-10June2008-0033.jpg)

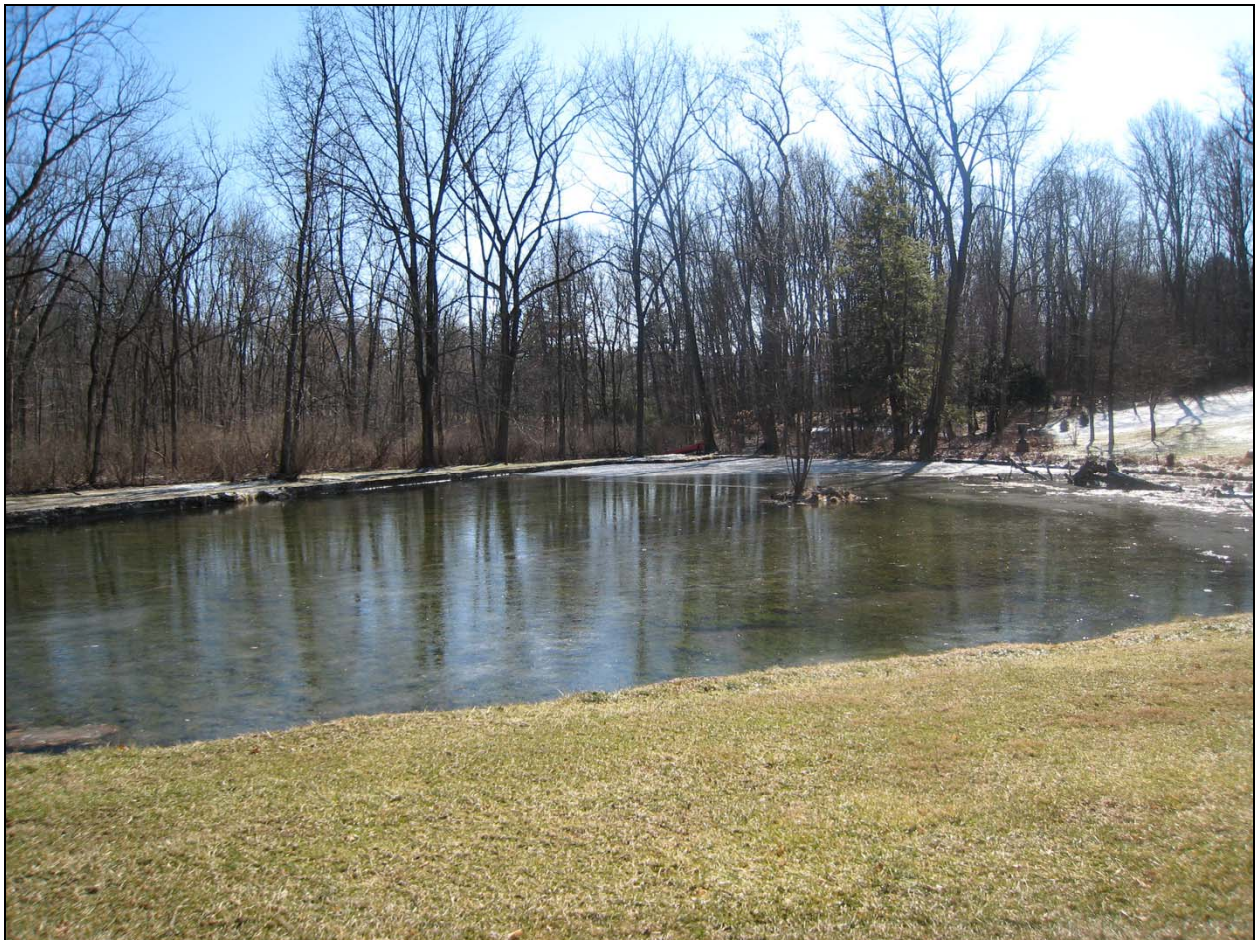
Figure III.14. A view looking southeast across the historic constructed pond shows a portion of the rusticated rock fountain at the pond center with a volunteer tree growing through it. The pond is a remnant character-defining feature of the Belair estate landscape, although today it is privately owned. Views of the pond are limited from the public landscape. Courtesy Heritage Landscapes. (R-MLW-11Feb2008__004.jpg)

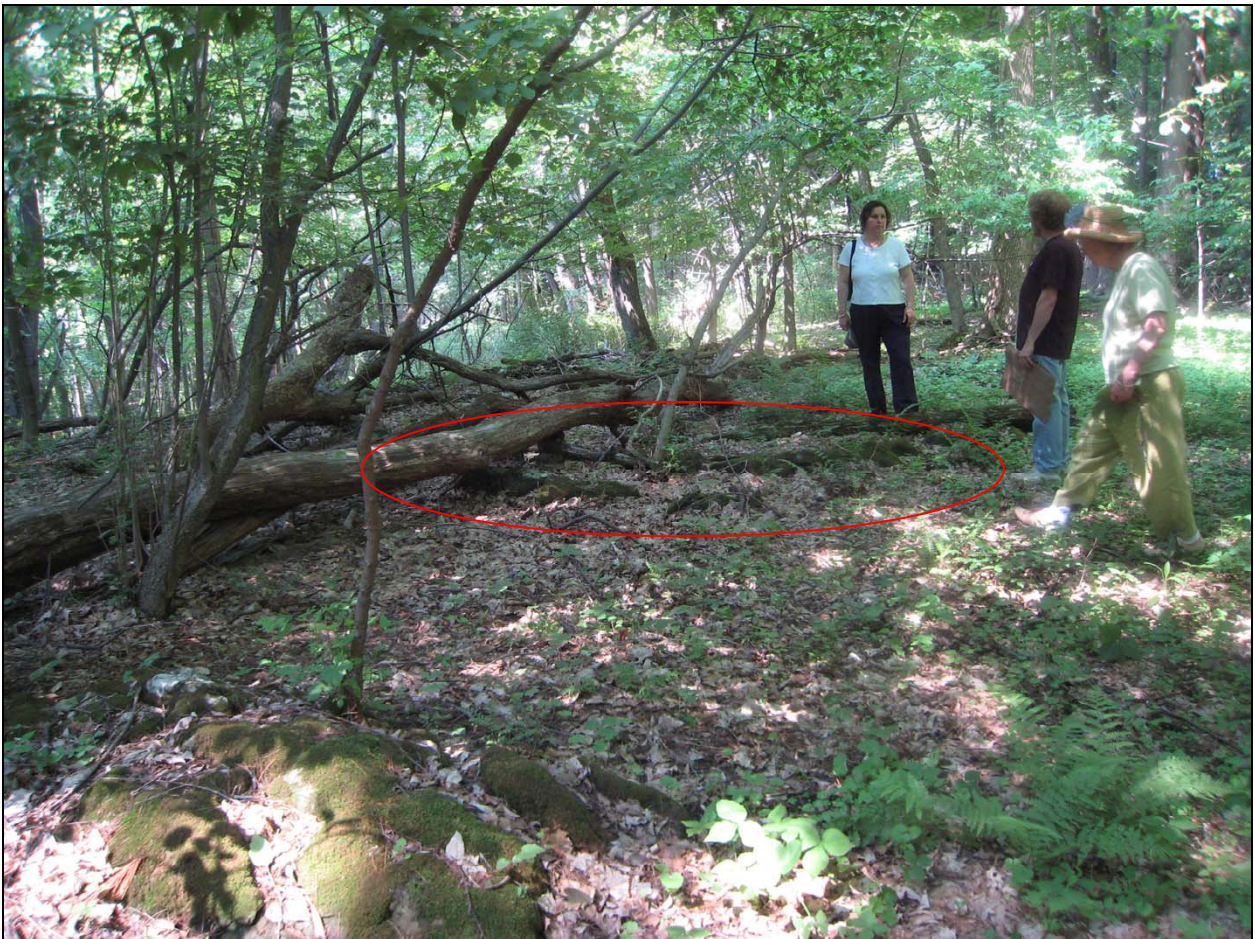
Figure III.15. Remnant historic stone features within the park landscape include the gazebo foundation, circled in red. The gazebo location is not along the pedestrian paths and the feature is obscured by fallen leaves, ground covers, and deadfall. Courtesy Heritage Landscapes. (R-MLW-10June2008-0179.jpg)

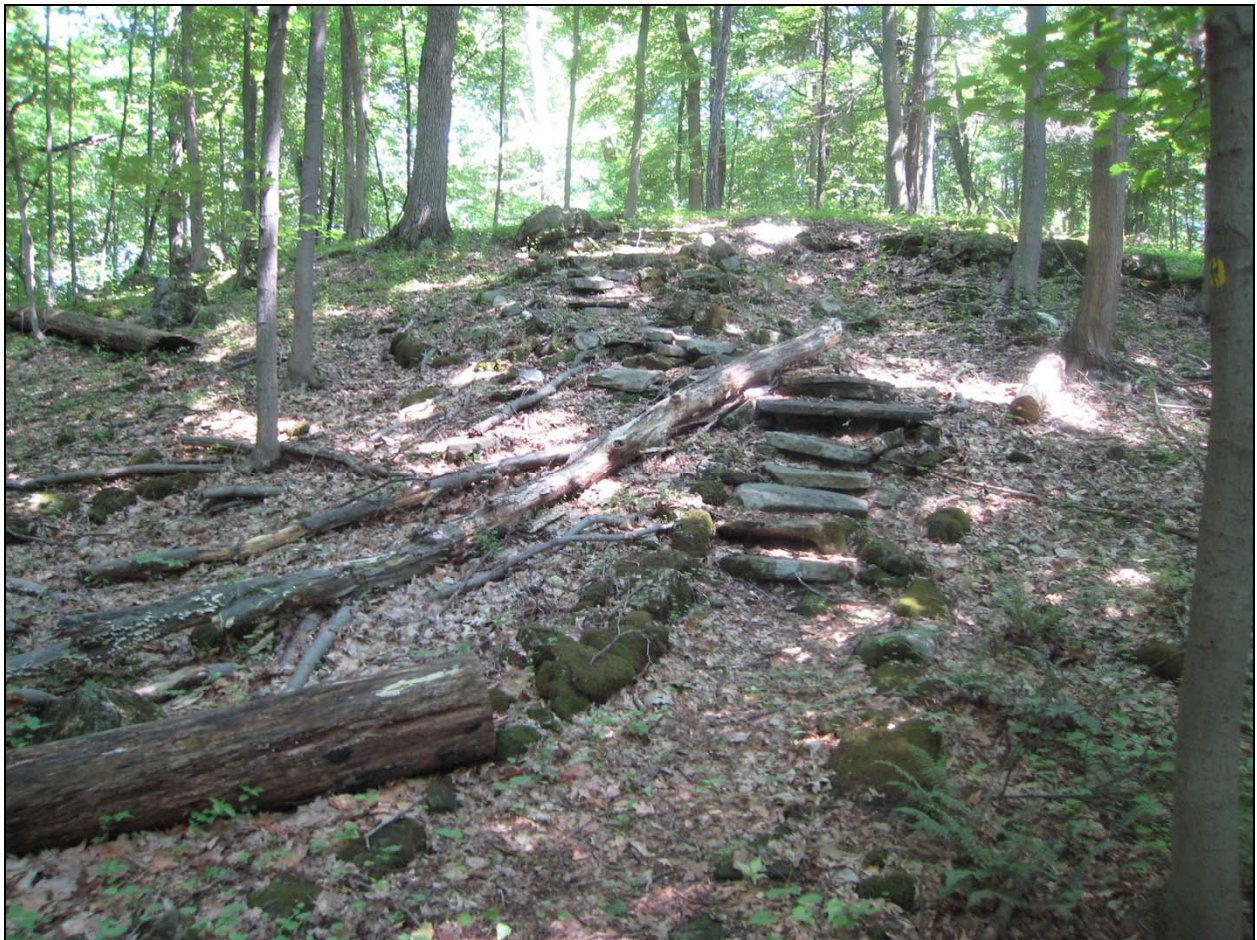
Figure III.16. A view along a gently curving stone stairway shows the remains of the historic estate feature. Several of the flat, bluestone treads have been removed. Stones continue to line the edge of the stairway. Fallen trees inhibit use of the historic feature. Courtesy Heritage Landscapes. (R-MLW-10June2008-0138.jpg)

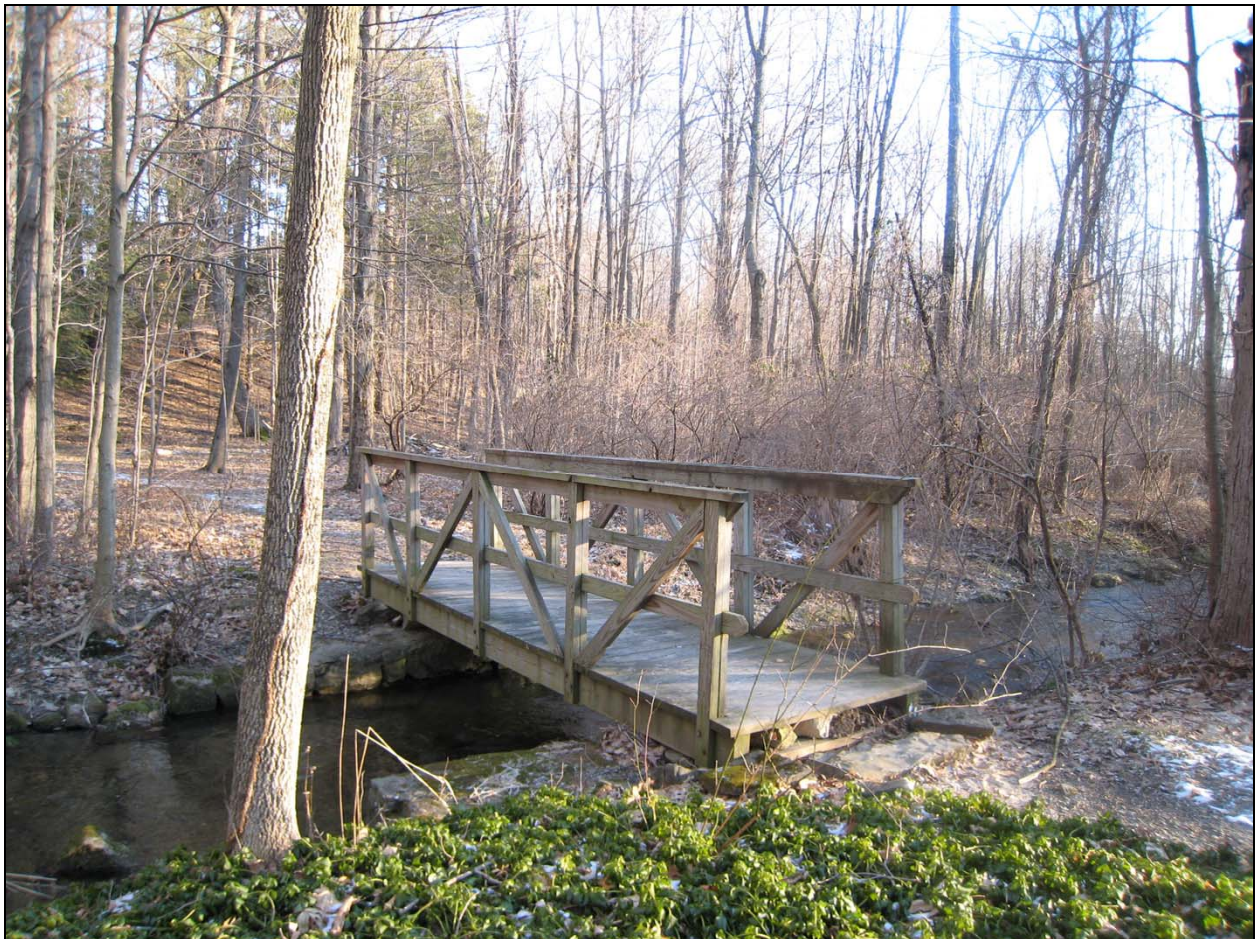
Figure III.17. A bridge constructed across the stream provides access to the woodland walking trails. The bridge was added after the end of the historic period. Stone abutments below the bridge are remnant historic features. Courtesy Heritage Landscapes. (R-MLW-11Feb2008__070.jpg)
