MADISON LEWIS WOODLANDS CULTURAL LANDSCAPE REPORT  
CHAPTER IV: MADISON LEWIS WOODLANDS LANDSCAPE  
ANALYSIS, INTEGRITY & SIGNIFICANCE

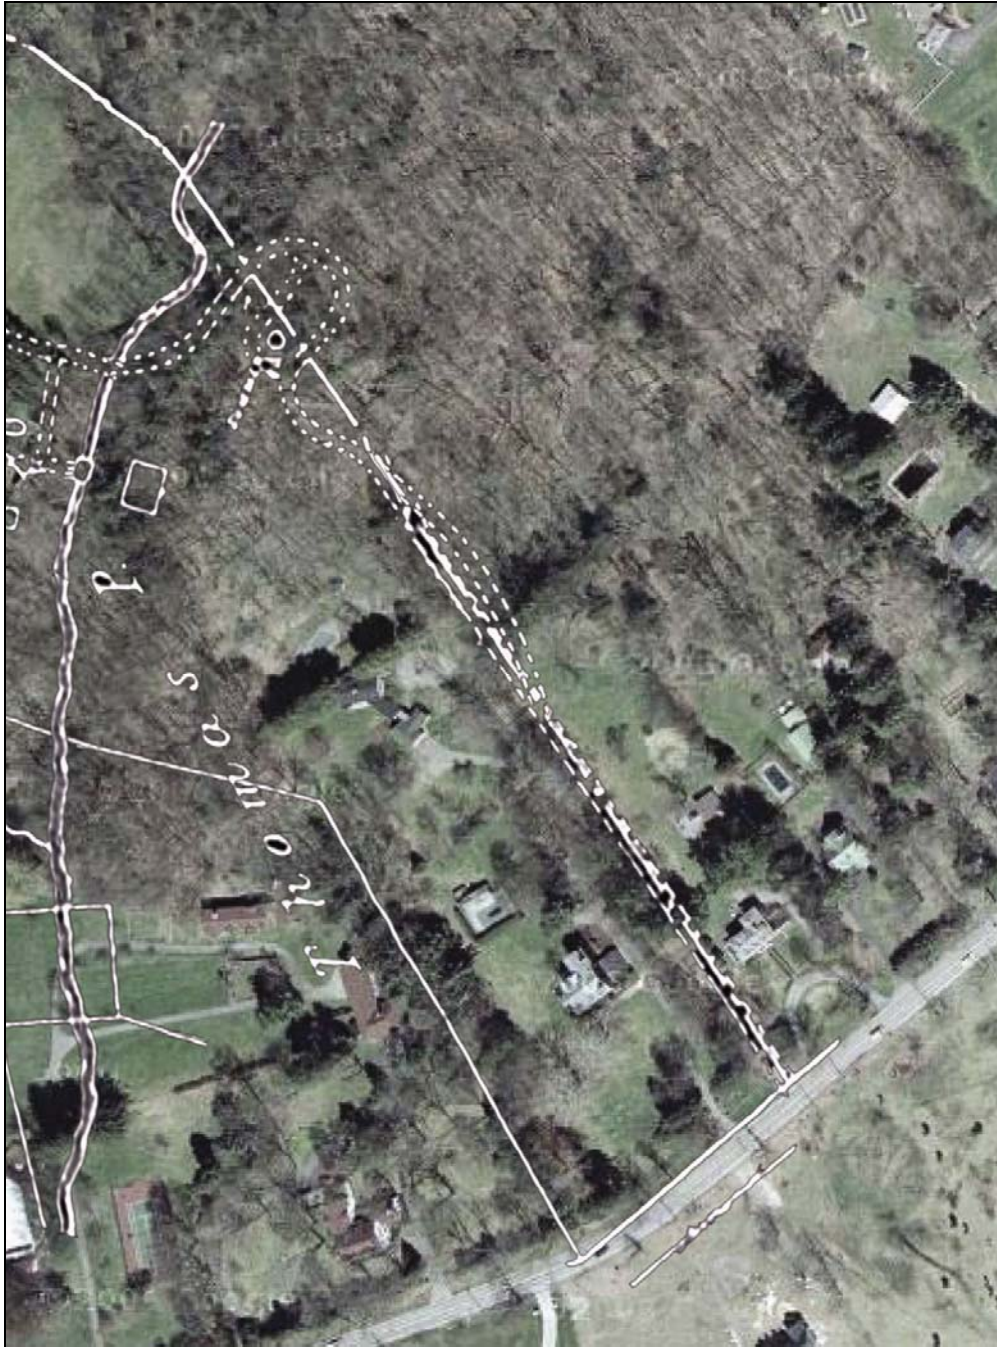
Figure IV.2. This image shows an overlay of a contemporary aerial with the 1903 Atlas of the Village of Warwick detail of Belair, focusing on the Colonial Avenue carriage drive. The entrance into the Madison Lewis Woodlands remains today, although it functions as a private driveway. Aerial courtesy Google Maps, Atlas courtesy Albert Wisner Public Library, overlay courtesy Heritage Landscapes. (R-MLW-Overlay-CurrentAerial-GoogleMaps-1903-Atlas-ColonialAlign.jpg)
