Fowler Garden Landscape Rehabilitation Madison Lewis Woodlands

February 2018

Prepared for
Village of Warwick
Warwick, New York

Prepared by
HERITAGE LANDSCAPES LLC
Preservation Landscape Architects & Planners
Charlotte, Vermont & Norwalk, Connecticut

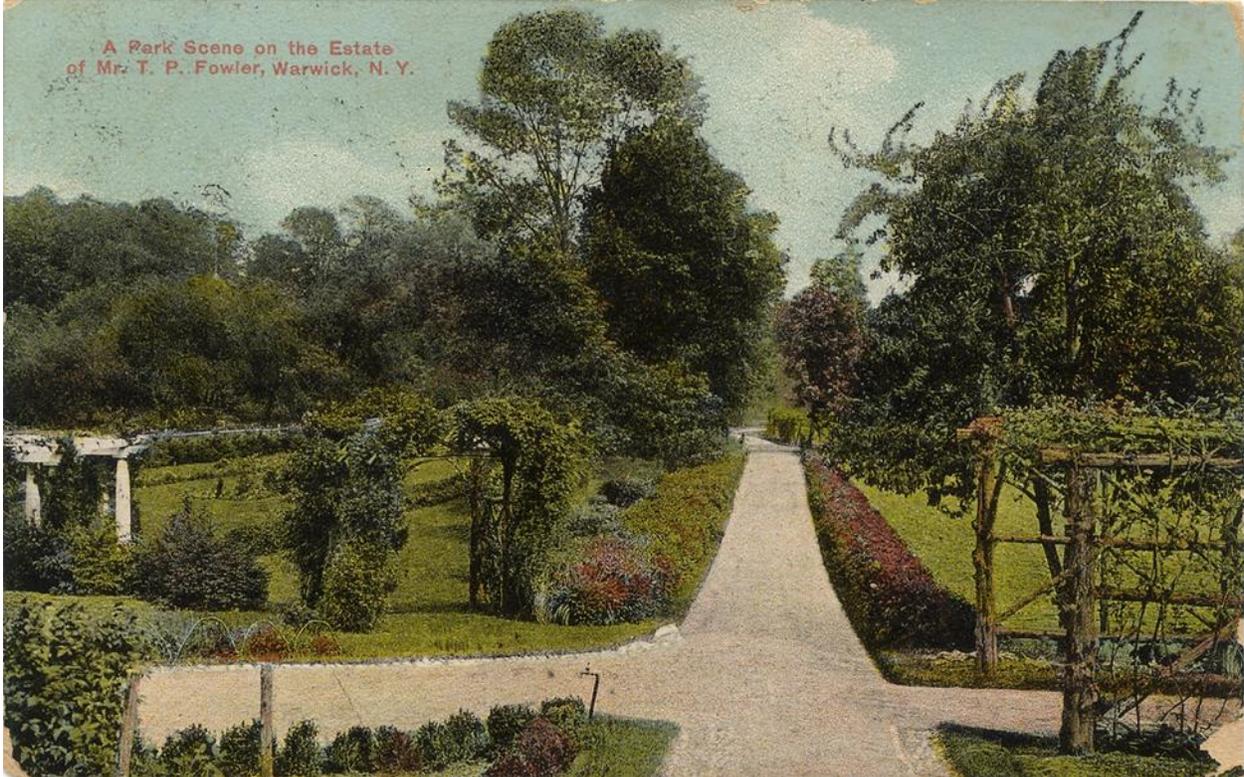
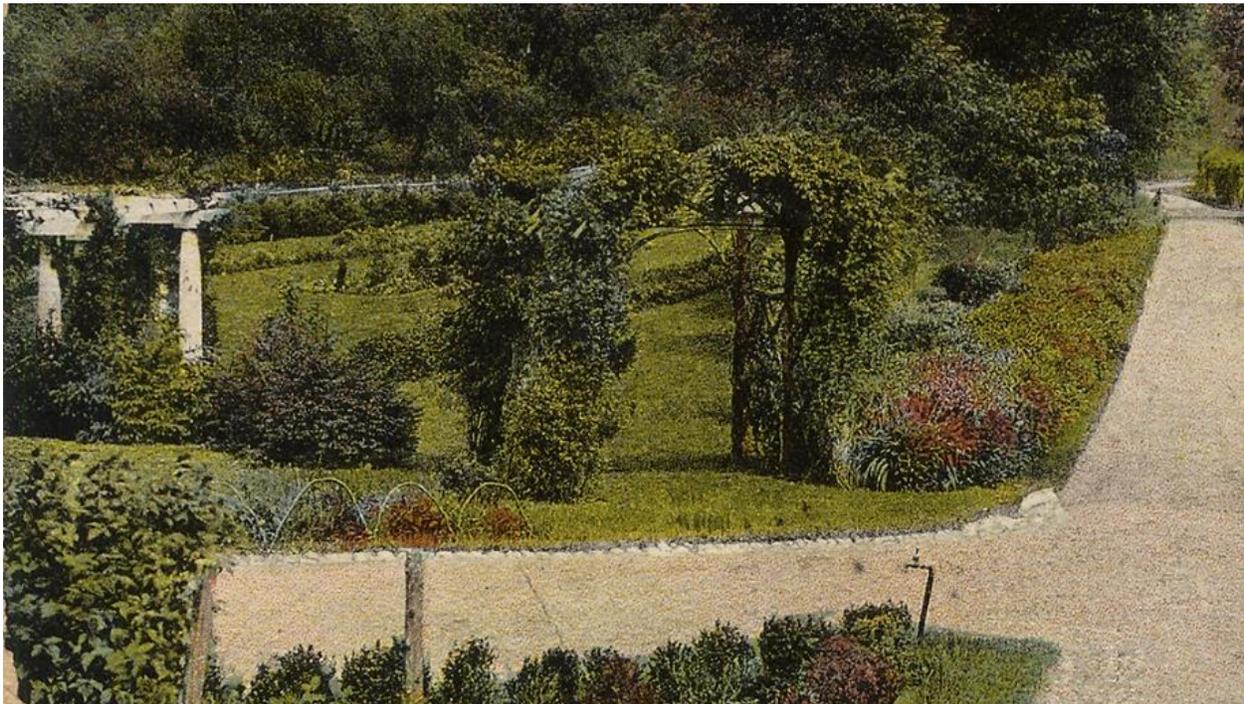
Figure 1.1a b This c1910 postcard photograph documents the Fowler Garden shows the vine-covered rustic wood arbor, at left, marking entry to the Fowler-era Italian Garden. Left of the entry arbor, the white pergola planted with vines inserts a formal character at the west end of the garden. Visible in the distance is the rustic bridge crossing Witches Brook. (MLW-VW-GardenAxis-1910)

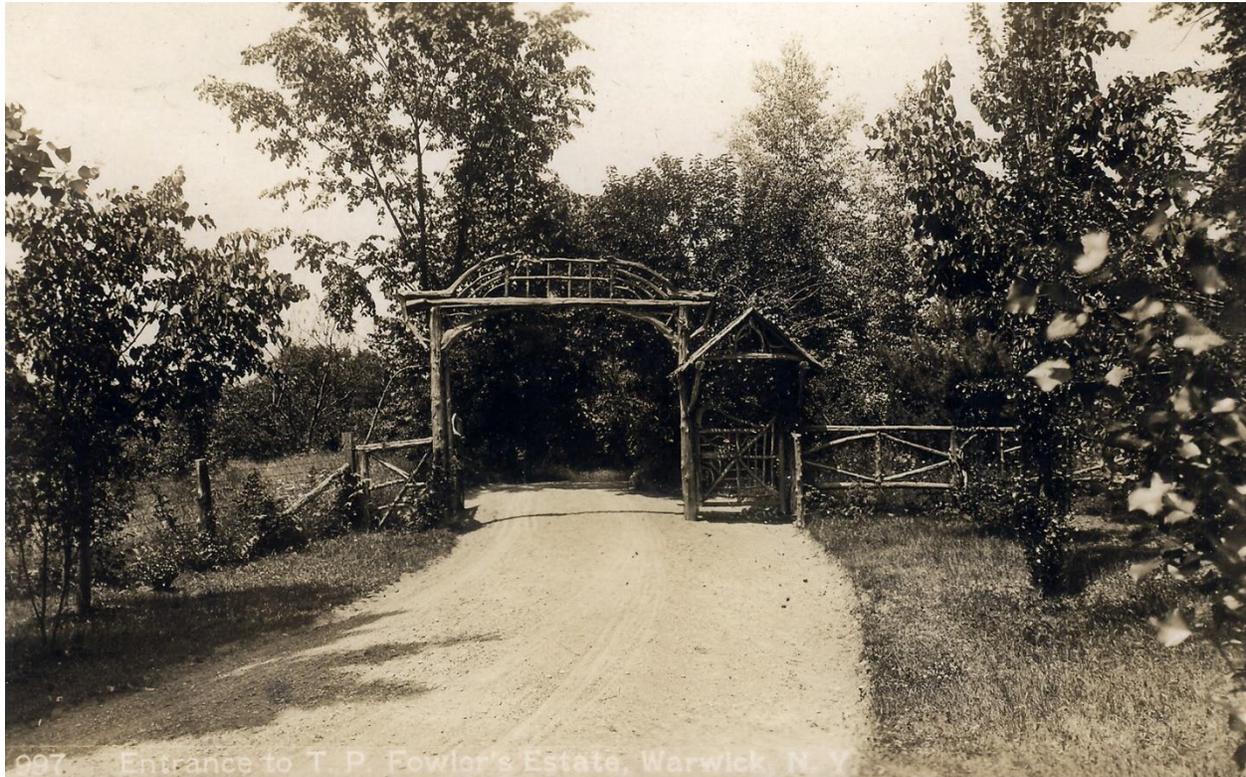
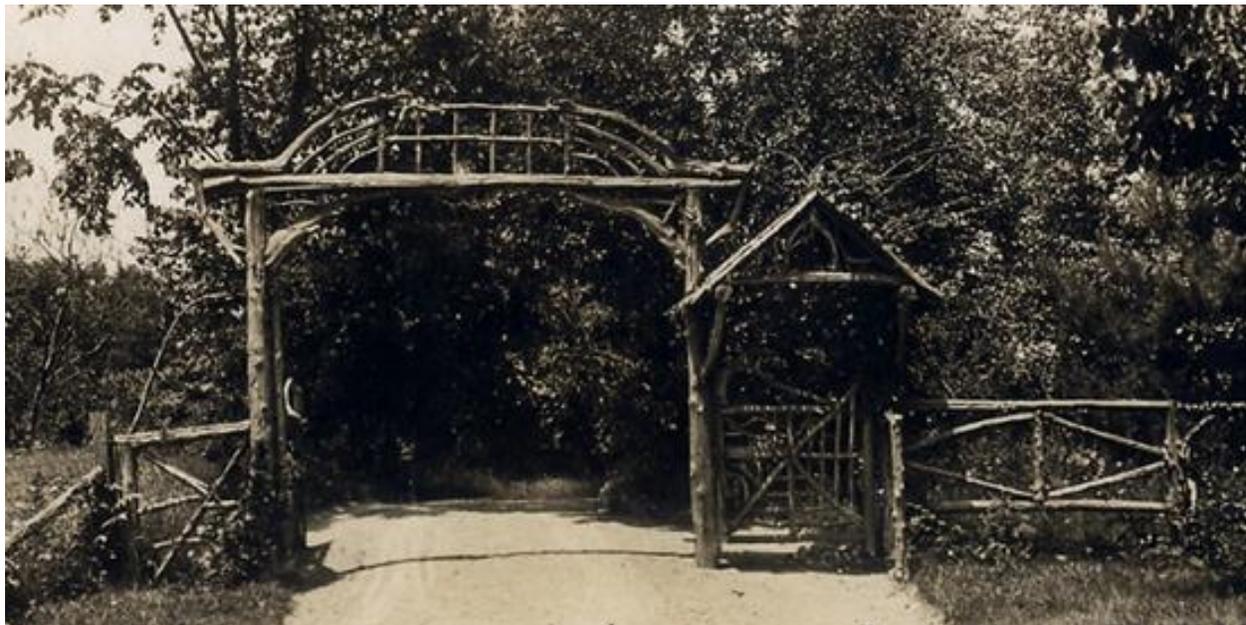
Figure 1.2a, b The use of rustic common red cedar (*Juniperus virginia*) logs and branches, bark on or peeled, defines the character of entries and boundaries throughout the Fowler Estate, as shown in this 1927 photo of a gateway and fence composition. (MLW-SG-GateDrive-1927)

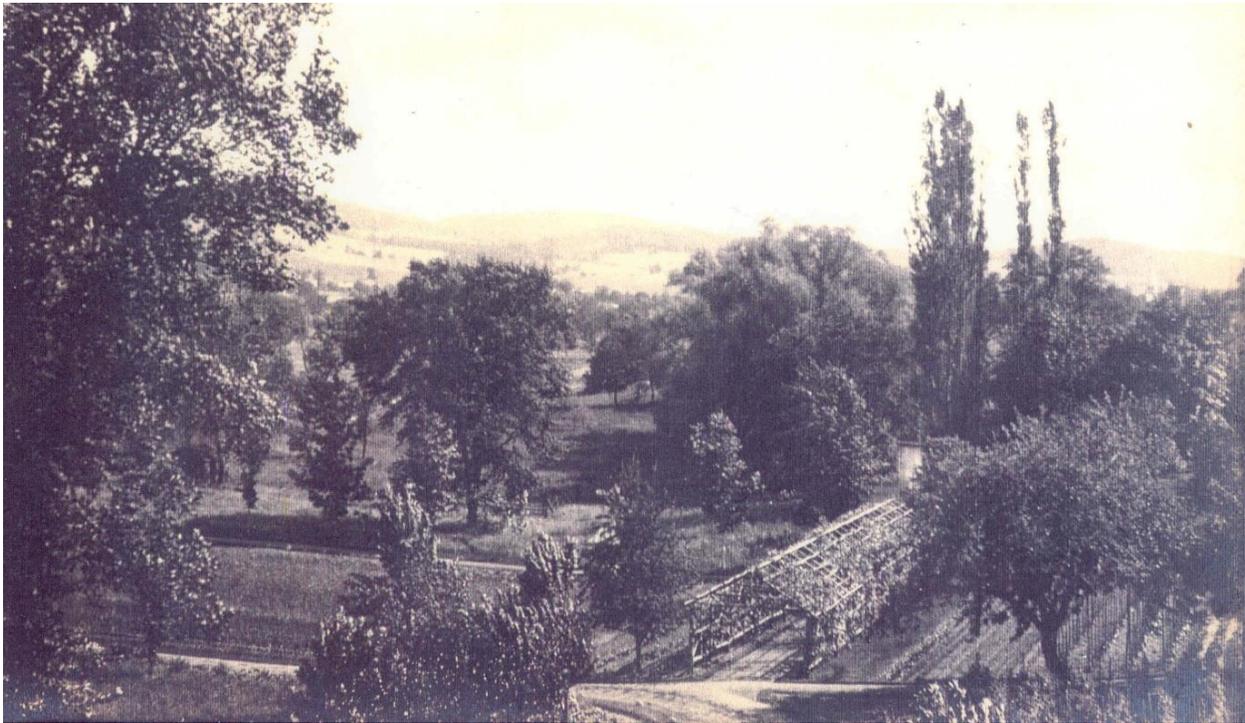
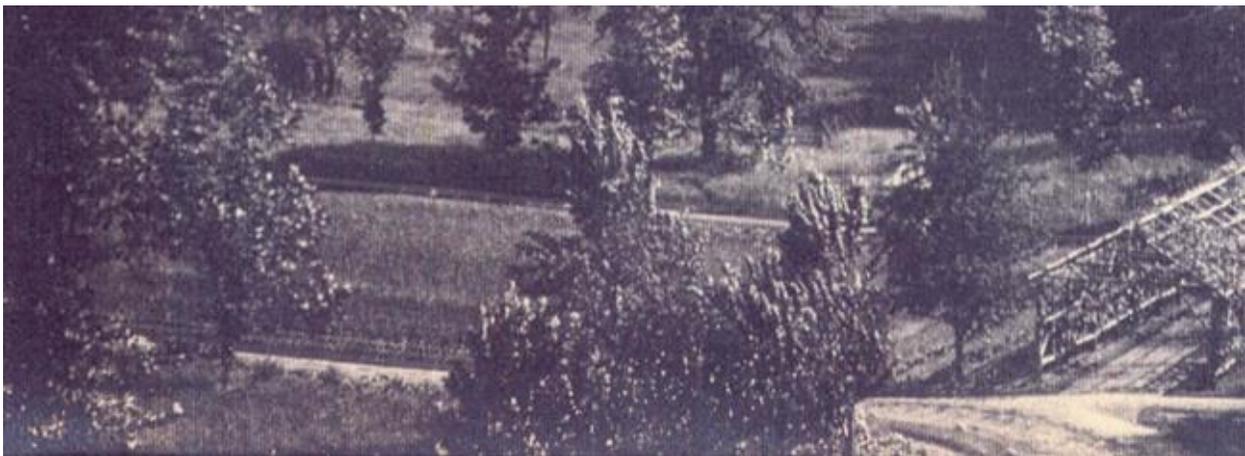
Figure 1.3a, b This c1902 view from stable/carriage house shows a portion of the carriage drive and intersection, the long rustic wood arbor and productive garden rows. The Italian garden extends beyond the frame of this image in the lower left corner. At the center, the long vine covered arbor leads past the tall Lombardy poplar trees to the ice pond. At right, the organized vegetable garden rows are visible. (MLW-VW-BA-FromStable-1902 cropped)

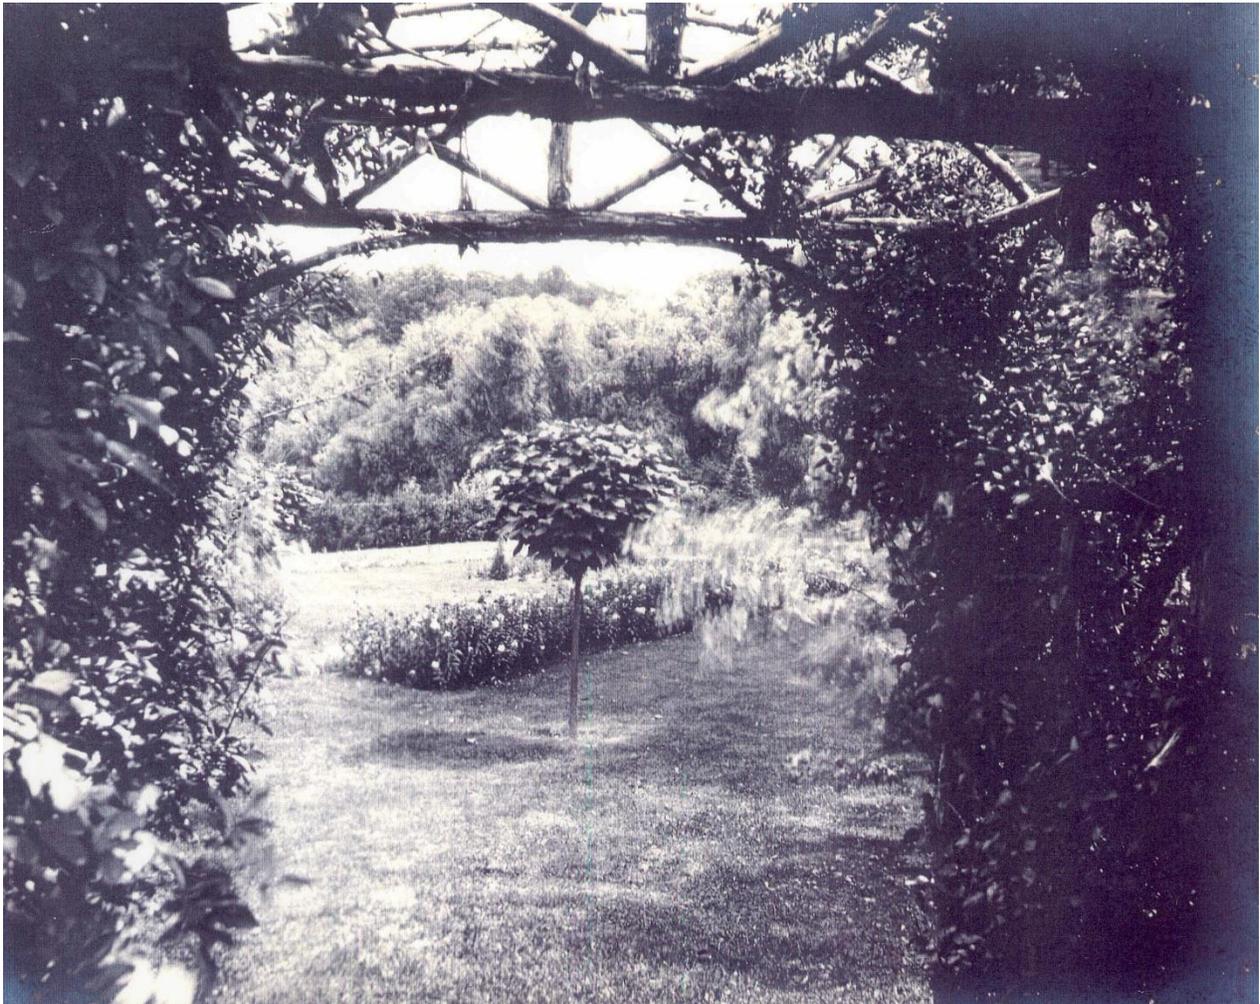
Figure 1.4 This 1910 view shows the rustic and densely planted arbor at the garden entry. Crafted of bark on cedar logs and branches, the structure created a framed threshold into the garden, with axial view to the dwarf umbrella catalpa and an angled view to the border and center beds. A mix of what appears to be climbing rose, honeysuckle and porcelain berry vine foliage creating a foliage and bloom covered archway into the garden. Porcelain berry and Japanese honeysuckle are both aggressive invasive exotic plants and other more well-behaved vines should be substituted. (MLW-VW-BA-GardenArbor-1910 Cropped)

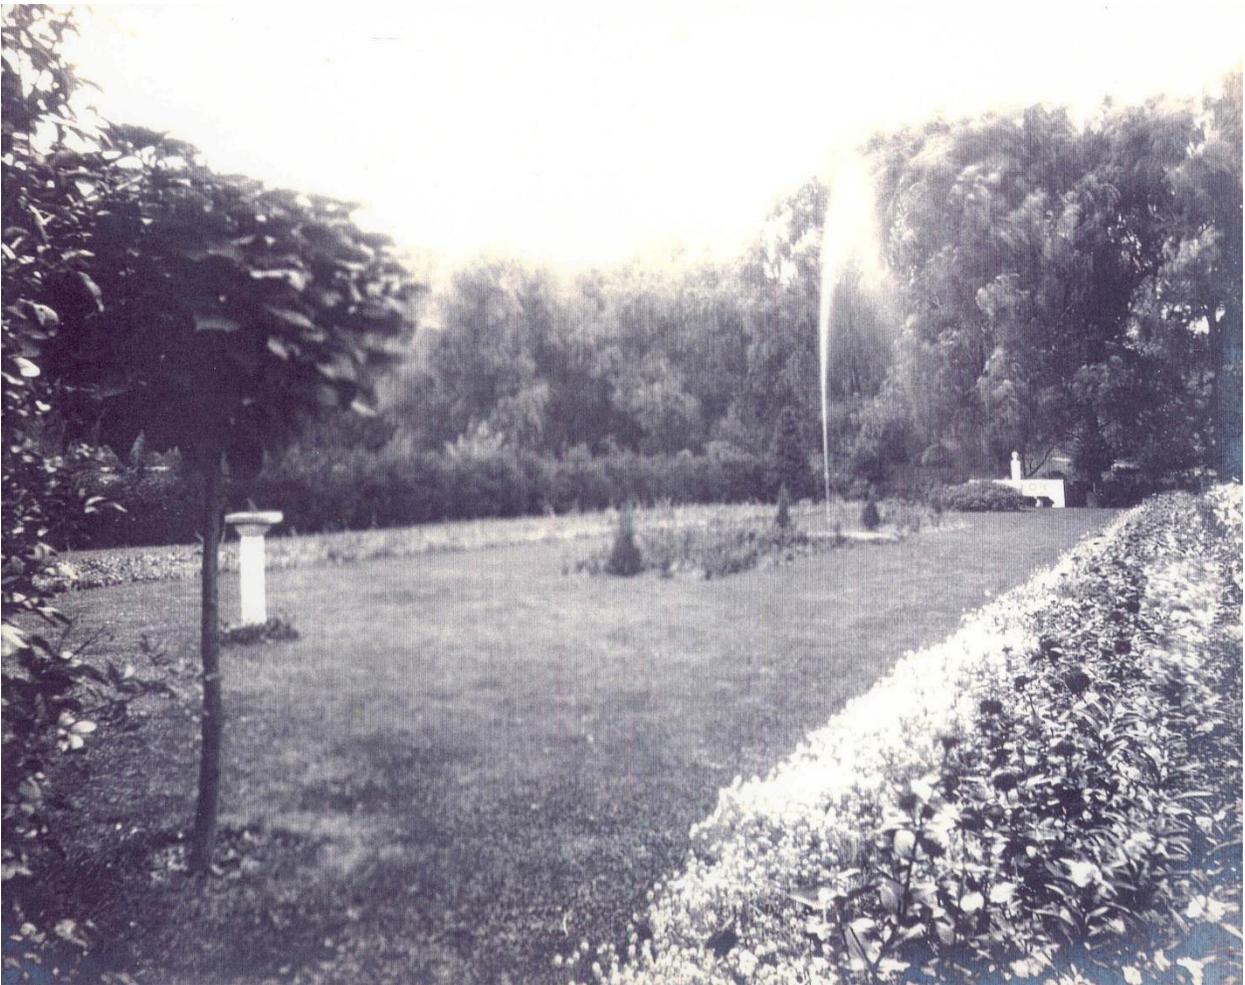
Figure 1.5a Two border planting beds are clearly visible in this 1910 view looking east across the formal lawn of the Italian garden. A clipped dwarf catalpa (at image left) is in front of the pergola and sundial. In the background, a line of white spruce tree forms the north garden border backed by willows. Note the great height and extent of the fountain spray in this view, which likely created damp surrounds. (MLW-VW-BA-Garden-1910-cropped)

Figure 1.18 Foreground plant in this view is *Lilium speciosum rubrum* in fall with the top showing the flower branches and a seed pod. Figure 1.5 shows the border with this plant form in the third row. (*Lilium speciosum rubrum* HL BRF fall 2017)

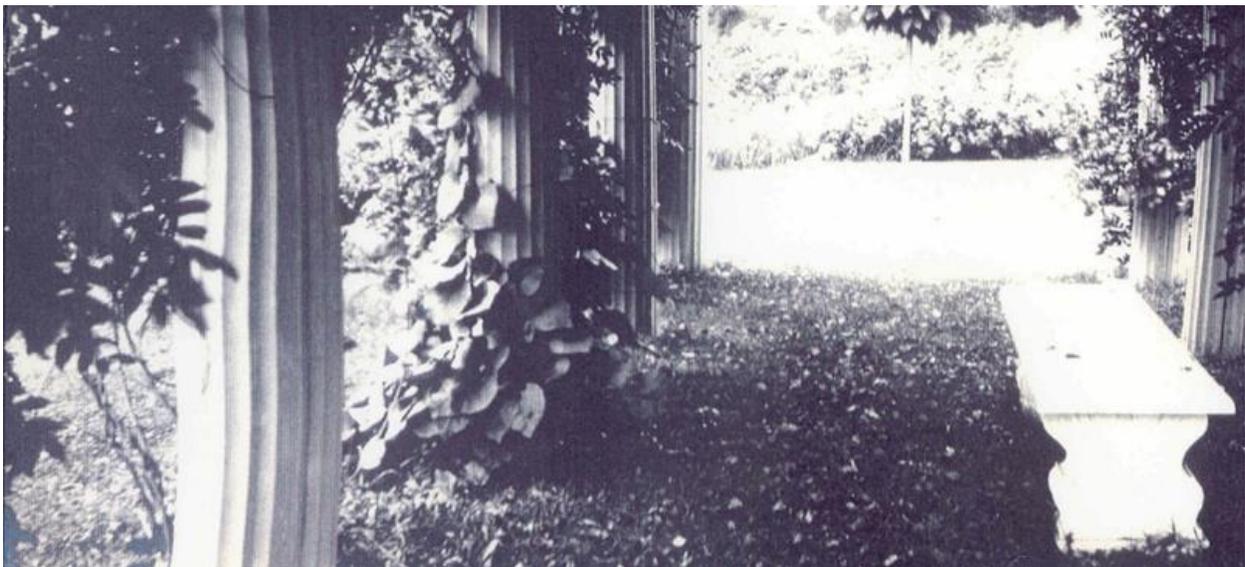
Figure 1.6a, b 1910 pergola axial view shows the fluted columns and classically inspired bench set in the grass which appears to be carved in stone or formed cast stone concrete. The trimmed dwarf catalpa tree provides the axial fulcrum centered in the view along the pergola, as it also does for the entry arbor. (MLW-VW-BA-Pergola-1910 cropped)

Stone benches centered along the south garden walk provide informal seating from which visitors can view in any direction. These could match the bench seen under the pergola (Figure 1.6). Since they are an addition, they could also be simple solid granite blocks and become part of the garden language without interpretation as an historic replacement. They would be highly durable and would not upstage the historic decorative elements. Fabricated in granite, they would require little maintenance while providing welcome seating for garden visitors.

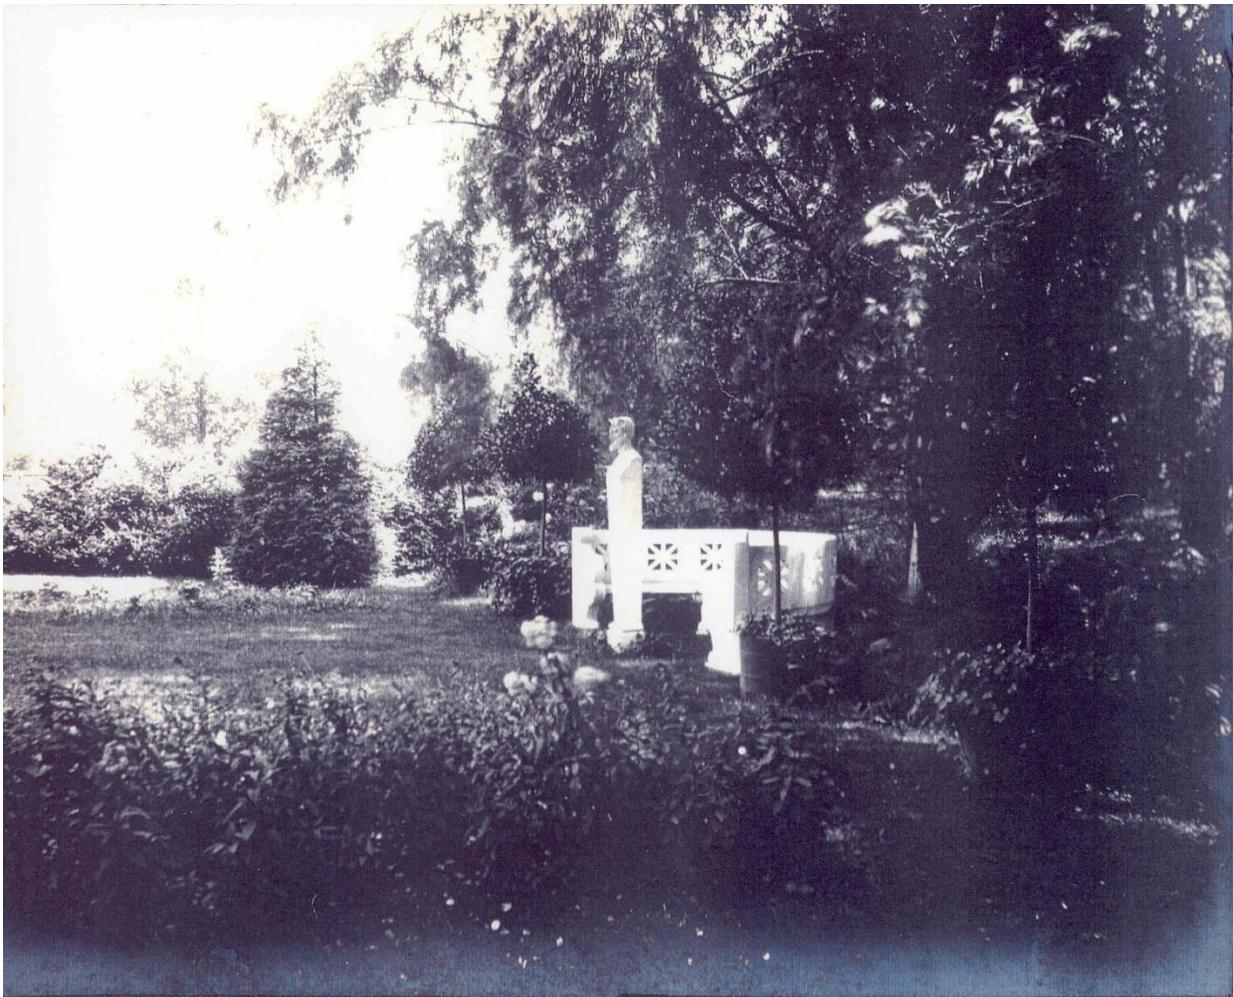
Figure 1.8 The 1910 garden as seen from the south looking toward the semi-circular carved marble bench and herm. Potted trimmed bay tree standards, set to either side of the bench in front of a shrub border planting would have been greenhouse grown and placed in the garden for the mild weather months. The flowering bed plants are seen in the foreground displaying what appears to be peony bloom above the foliage. (MLW-VW-BA-GardenBust-1910 cropped)

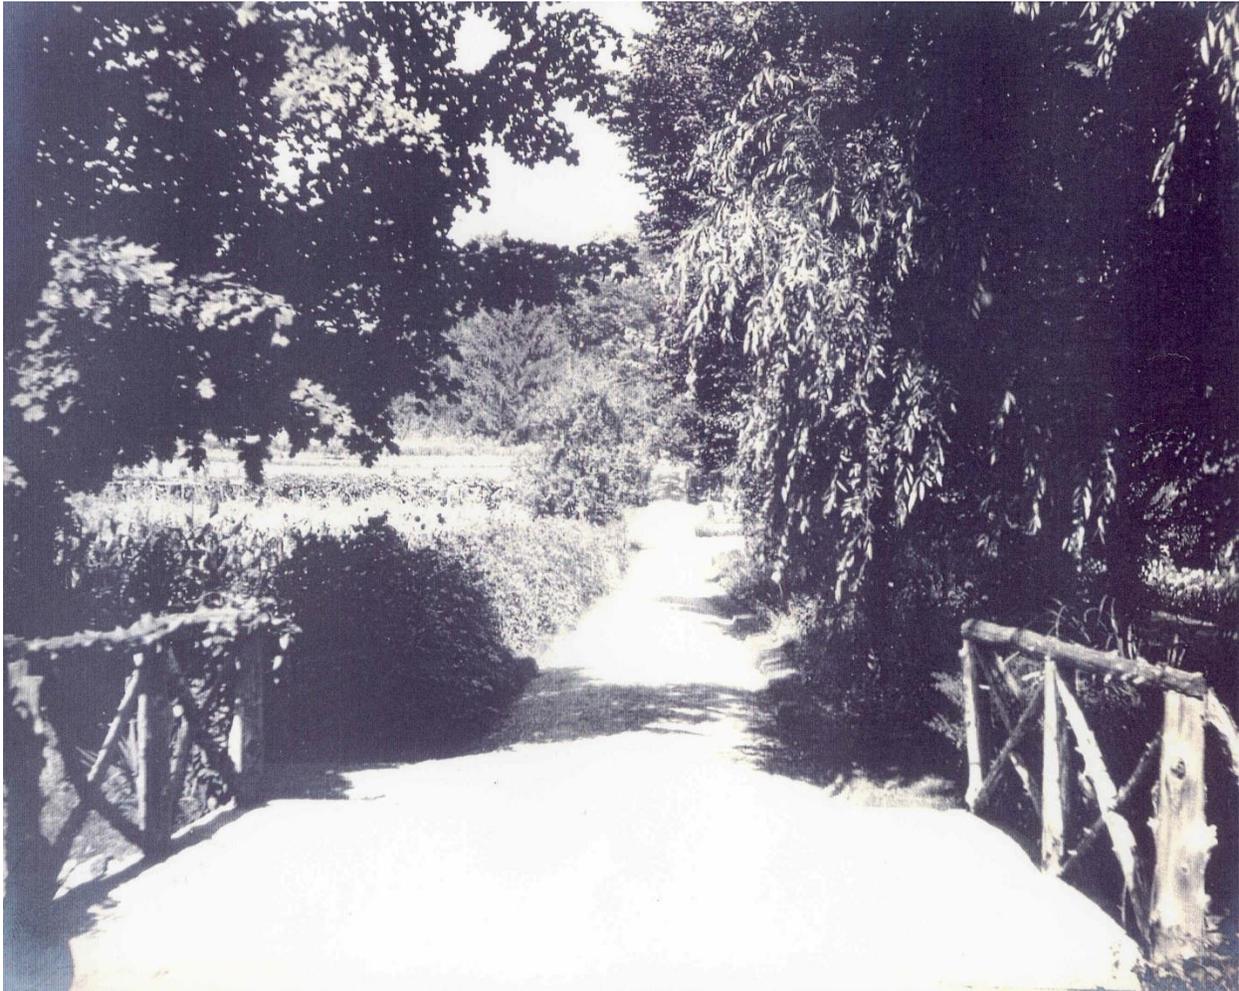
Figure 1.9 Looking west across the rustic bridge at the crossing of Witches Brook on the approach to the main house from the historic Colonial Avenue carriage path entry drive. The formal garden would be positioned behind the screen of willow trees to the right. The bridge, possibly with a wood deck and displaying a peeled log railing, was constructed at a width to accommodate vehicles. It provided access between the main house, and tennis courts and play house on the east side of Witches Brook. (MLW-VW-BA-CarriagePath-1910 cropped)

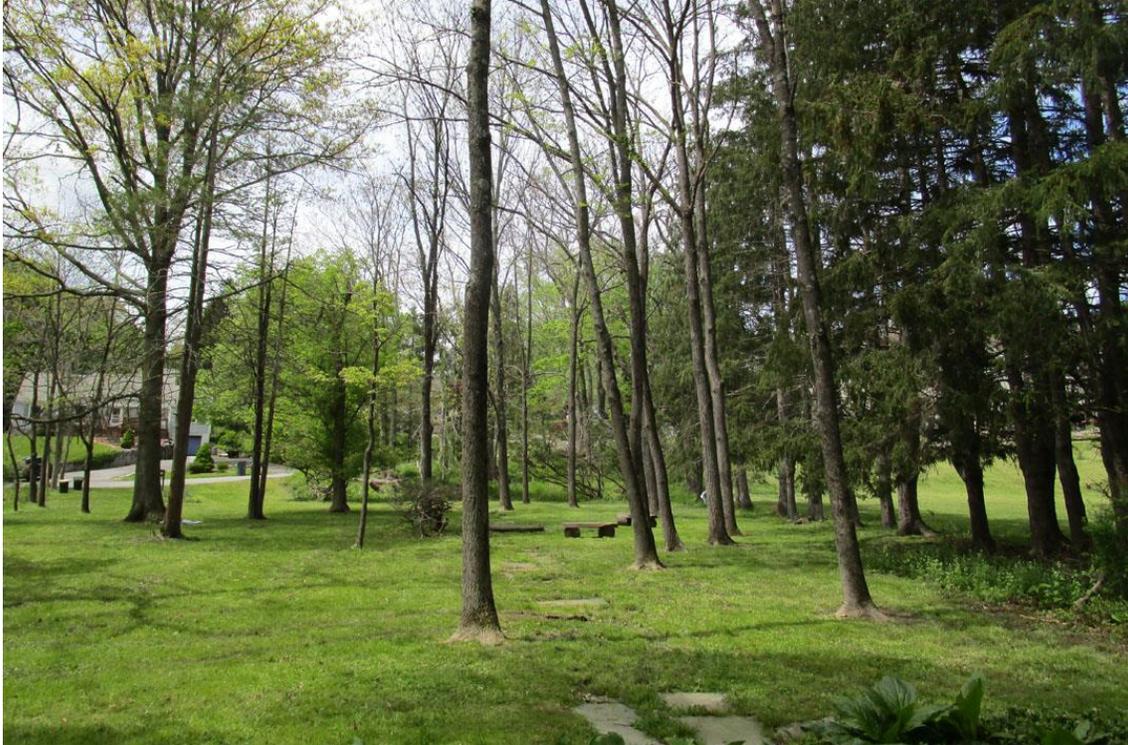
Figure 1.11 A 2017 view west across the remaining one-half acre Fowler Italian Garden shows black walnut trees self-sown and turf. The garden retains aspects of historic organization, as topography, original spruce trees to right, and fountain basin remain as clues. The area serves as an entry point into the Madison Lewis Woodland. (MLW-View West 2 2017 May 10 (56))

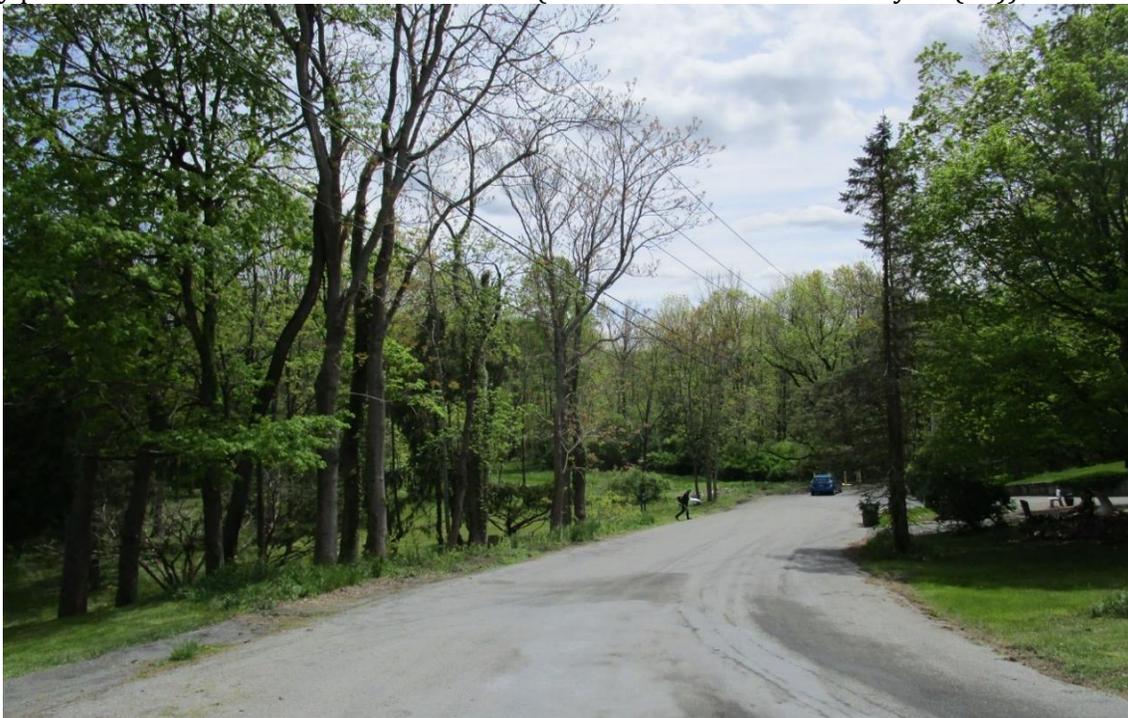
Figure 1.12 A wider Robin Brae Drive to the west of the garden reflects the original alignment of the carriage drive. The widening of the road surface likely caused altered topography at the top of slope along the gardens west perimeter, at left. (MLW-Brae Dr 2017 May 10 (75))

Landscape Report, and undertook a detailed field investigation to document the existing conditions of the former garden to build a base map for the garden rehabilitation treatment plan. Using the 2008 base information Heritage Landscapes staff undertook a detailed field investigation to document the landscape develop an updated base map. **Plan 2: 2017 Plan**, captures the current state of the one-half acre historic garden area, documenting the current landscape of the former Fowler Italianate Garden. The garden location is generally true to its historic location on the former grounds of the 38-acre Belair Estate with its organization and several garden features remaining from the original garden design. This includes rectilinear form, topography, the central fountain basin and line of white spruce at the north border (Figure 1.11). Changes have occurred over the last century, altering the character of the garden primarily through the significant loss of planting beds, flowering and ornamental plant materials and garden structures. The garden shape may be slightly narrower to the west where land was lost in the widening of Robin Brae Drive prior to the 1966 Garden Club ownership (Figure 1.12).

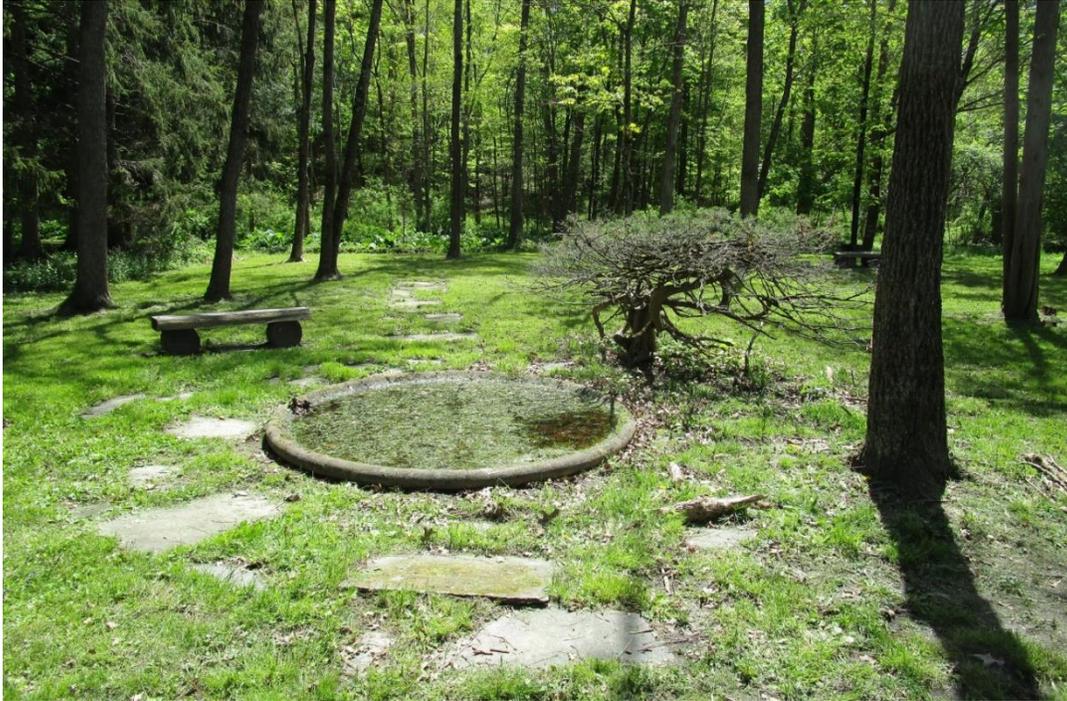
Figure 1.13 The historic concrete fountain basin remains as the central focus of the former garden. No longer functional as a fountain, the basin retains rain water providing still water for birds. Flagstone around the fountain is undocumented. The contemporary bench was added. (MLW-Fountain 2017 May 10 (2))

The Fowler Italian Garden fountain basin remains in its original location at the focal center of the historic garden. The 8 foot diameter precast concrete dish is weathered in appearance showing integral aggregates of the concrete mix in the granulated exterior and appears to remain functional with holding of storm water and no apparent fissures or cracking of the concrete. As the only remaining built element of the historic garden, conservation and return of this basin to an operational status is recommended. In returning this basin to an operational status, a better understanding of its current condition will need to be undertaken. The concrete will need to be cleaned and inspected in determination of any needed repairs and conservation treatments. Restoration of the fountain's water recirculation system and plumbing involves modest utility work to bring water and electric supply lines from the adjacent Village utilities on Robin Brae Drive to provide a water supply and operate a small pump for a central fountain jet. An overflow water line from the basin to Witched Brook will divert storm water from spilling over the basin edge to the adjacent planted border. Water supply and return lines from a small utility vault will operate the center jet. The vault will conceal the pump and small water storage tank and electrical service for the fountain.

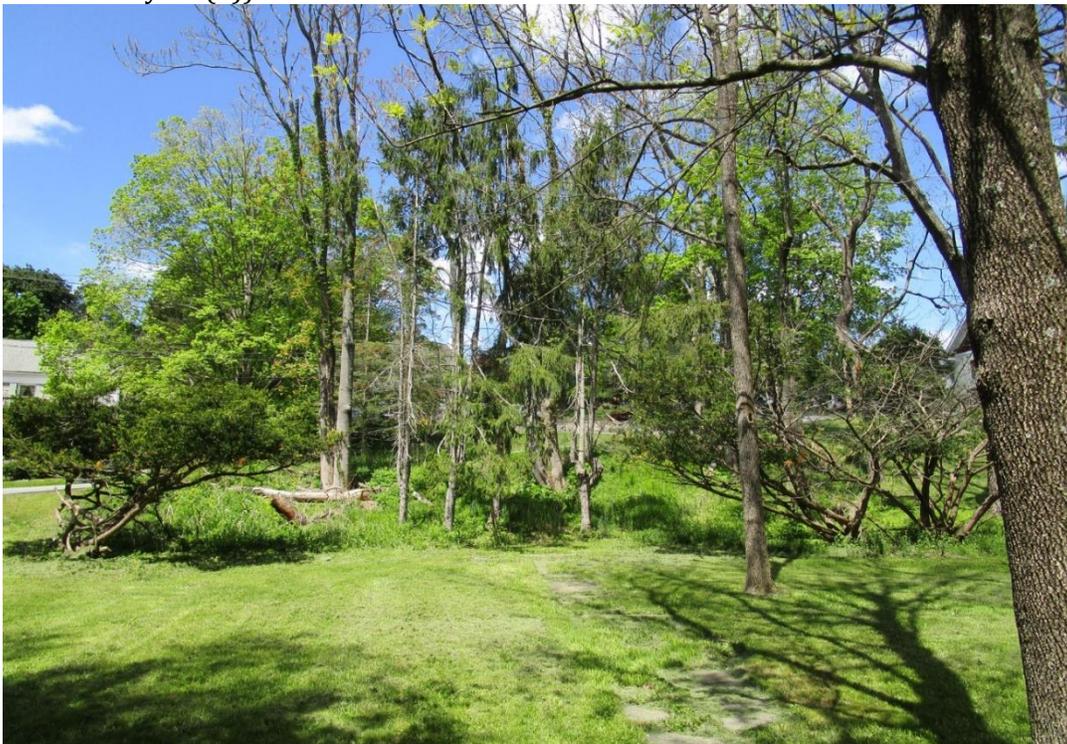
Figure 1.14 The location of the former vine covered pergola at the toe of the west slope is demonstrated by the two pairs of overgrown and misshapen yews. Individual trees from the historic white spruce line are also visible. Up the slope from the spruce, volunteer Tree-of-Heaven, (*Ailanthus altissima*) and invasive vines have taken hold. (MLW-Pergola 2017 May 10 (6))

The flanking pairs of yew shrubs in place today are misshapen by former covering growth now removed. These shrubs do not appear in the 1910 era views. Rather, four dwarf umbrella Catalpa trees are arrayed to the east of the pergola. Planting evergreen shrubs along the new deer fence line is recommended. The use of a dwarf yew, such as *Taxus x media* 'Everlow' would suit the location or another form of yew or holly could be used there. Note that all parts of taxus are poisonous, and the red berries are attractive, therefore not using them in a public garden may be preferred.

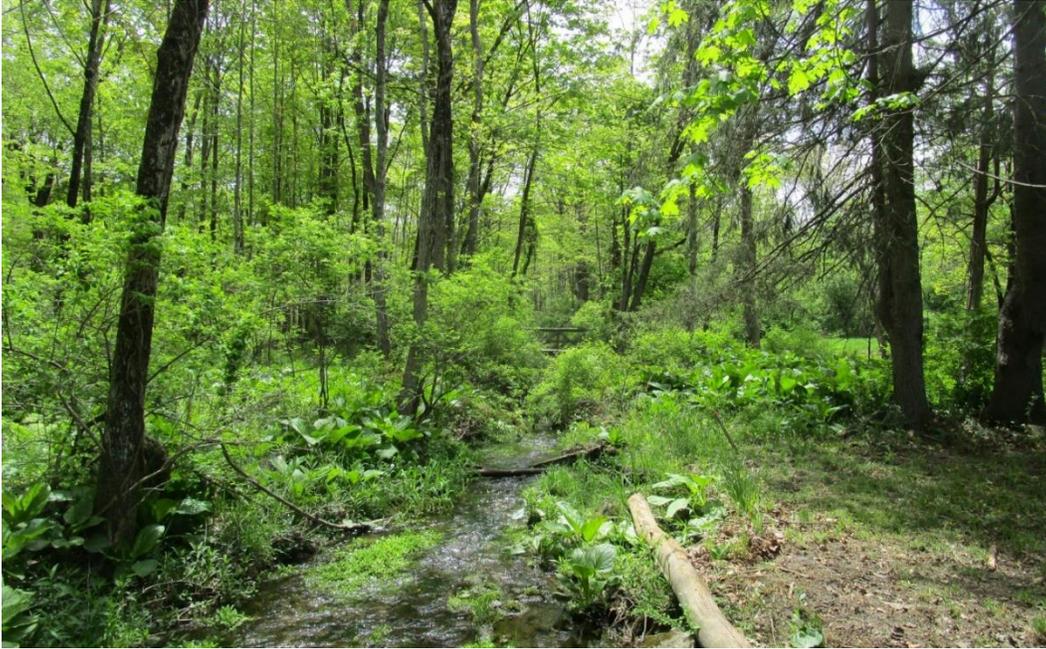
Figure 1.15 This view south along Witches Brook shows the loss of garden character between the brook and the east end of the Fowler Garden, at right and extending off frame. Vegetation has become more naturalistic following loss of white willow canopy and mixed evergreen shrub and herbaceous plantings that historically marked the border of the formal garden. (MLW-Witches brk 2017 May 10 (52))

Witches Brook along the east perimeter remains active although the willow trees are no longer on the west bank and the rustic wood bridge was replaced with a narrow timber pedestrian structure atop the historic stone footings (Figures 1.15 and 1.16). A small pollinator garden located just behind the wood Madison Lewis Woodland entry sign is a recent addition in the former garden in the approximate location of the historic rustic arbor marking the entry at the corner of the garden (Figure 1.17).

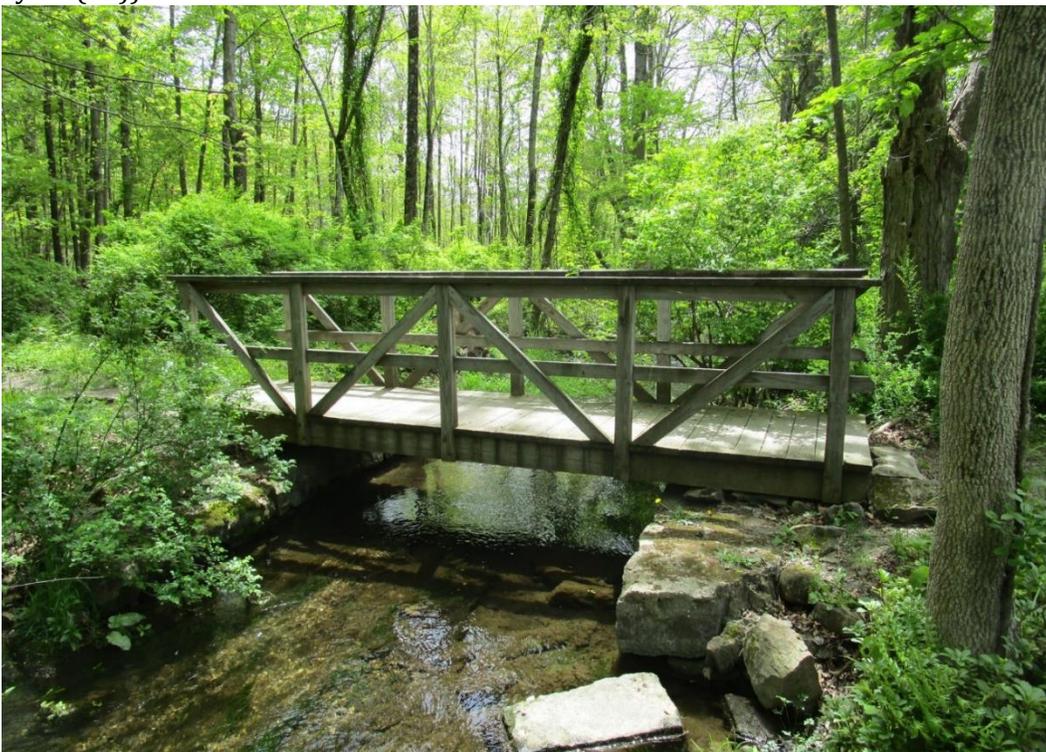
Figure 1.16 A contemporary pressure treated wood bridge has replaced the historic wood deck bridge with rustic cedar log railings. Built atop the historic stone footings, the new bridge is sized to accommodate pedestrians rather than vehicles. It serves as the primary access to the Madison Lewis Woodland trails from Robin Brae Drive. (MLW-Bridge 2017 May 10 (40))

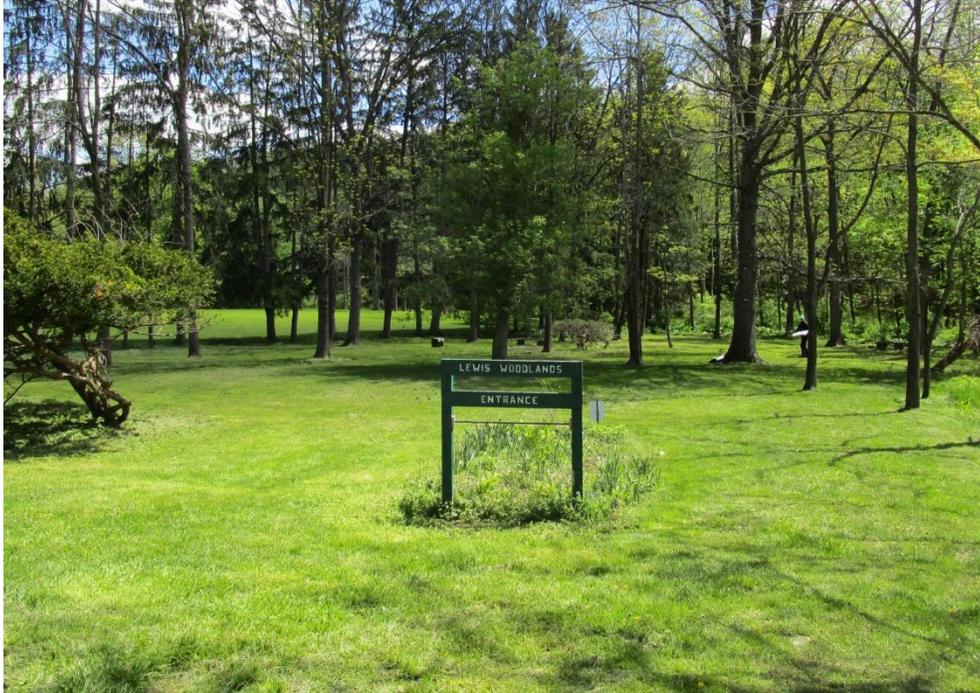
Figure 1.17 A small pollinator garden is planted near the wooden Madison Lewis Woodland entrance sign. The sign and garden are in the approximate location of the historic rustic arbor at the southwest corner of the formal garden. The former carriage drive and bridge across Witches Brook is out of frame at image right. The loss of planting beds and garden structures has degraded the spatial organization and legibility of the historic garden character. (MLW-Entry 2017 May 10 (15))

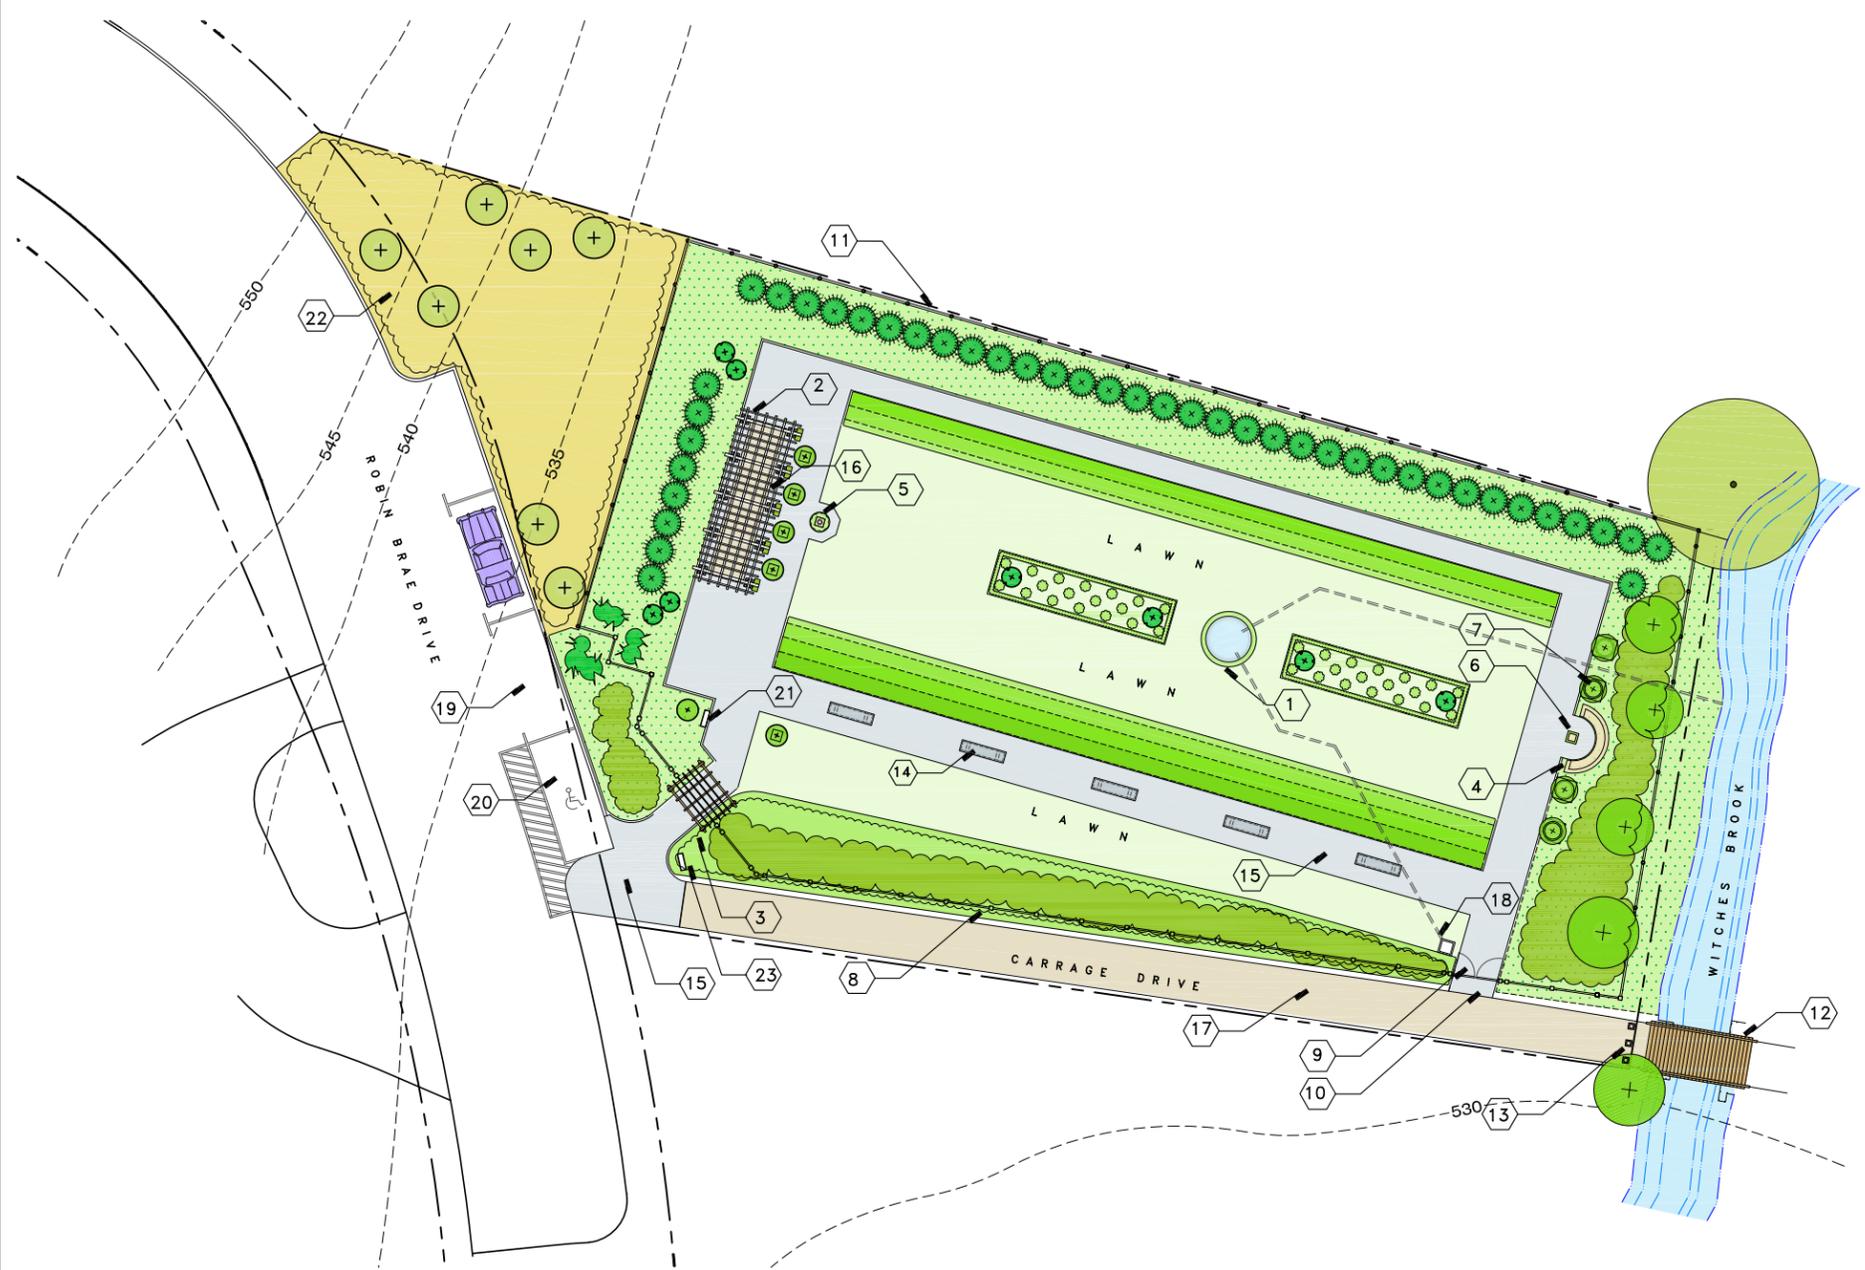
| | PROPOSED UMBRELLA CATALPA | | |

SOURCES:
 2016 AERIAL PHOTOGRAPH, GOOGLE.COM
 2017 FIELD RECONNAISSANCE, HERITAGE LANDSCAPES
 BEL-AIRE ESTATES 1952 PLAN, VILLAGE OF WARWICK
NOTE:
 PROPERTY LINES TAKEN FROM FIELD MEASUREMENT OF ON-SITE PINS. ACTUAL PROPERTY LINES REQUIRE SURVEYOR SURVEY.
